**IC Corporation**

## **RECALL NOTICE**

**IC CORPORATION RECALL # 04305**  
**NHTSA RECALL # 04V- 498**

### **30-Inch Child Restraint Seat Cushion Retention**

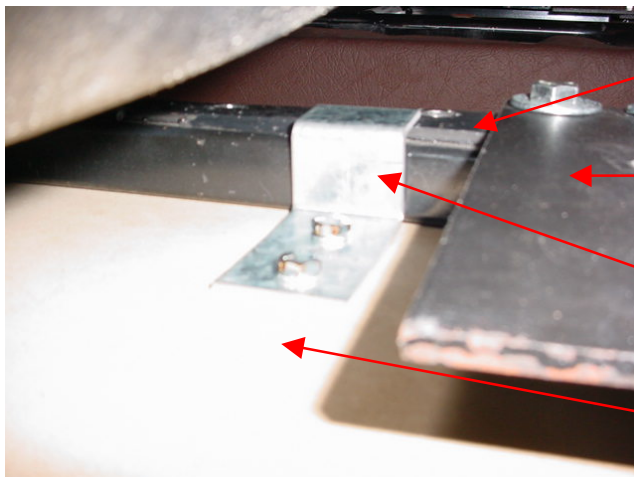
**Rectangular support is located in rear portion of seat cushion frame.**

**Reinforcement on aisle side of seat frame.**

**Z-shaped clip installed approximately 1-inch from reinforcement plate.**

**Under side of seat cushion.**

1. Make sure that the cushion is in place and snug against the sidewall of the bus.
2. Using the metal Z-shaped clip, hold in place against the rectangular rear longitudinal bar and the board on the bottom side of the seat cushion. Leave about 1-inch between edge of clip and seat frame reinforcement plate.

11. Return seat to the proper position, which requires the seat cushion to be tight against the wall of the bus.
12. Using two (2) 1/4-inch bolts with 1/4-inch lock washers, secure the z-shaped clip to the board using the T-nuts just installed. These bolts must be inserted into the nut insert that was just installed.
