VEHICLE RECALL

**G-03508
May 2003**

**SUBJECT: SAFETY RECALL (U.S., EXPORT)
Tail Pipe Exhaust Single Band Clamp on 9000 Series
Models built 11/15/2002 through 3/12/2003 with
Caterpillar Engines.**

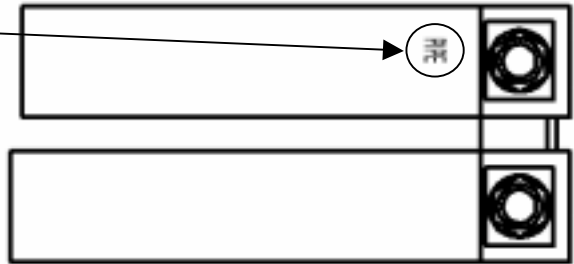
1. Remove Single Band Clamp.
2. Note the correct orientation of Double Band Clamp:

- Tail pipe side stamped "PIPE"

- Muffler side has no stamp

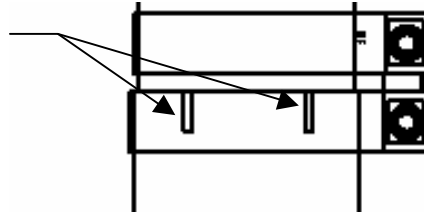
Muffler Clamp must cover all slots completely to avoid a loose joint or leaks.

9. Position muffler side clamp flush with top edge of muffler discharge.

10. Torque both clamp bolts to **27-37 lb-ft** (37-50 N-m).
