**ADDENDUM # 2 TO IC CORPORATION RECALL # 03306**  
**NHTSA RECALL # 04V-010**

**REF: Modesty Panel at Front Barriers**

IC CORPORATION RECALL # 03306  
NHTSA RECALL # 04V-010

## Modesty Panel at Front Barriers

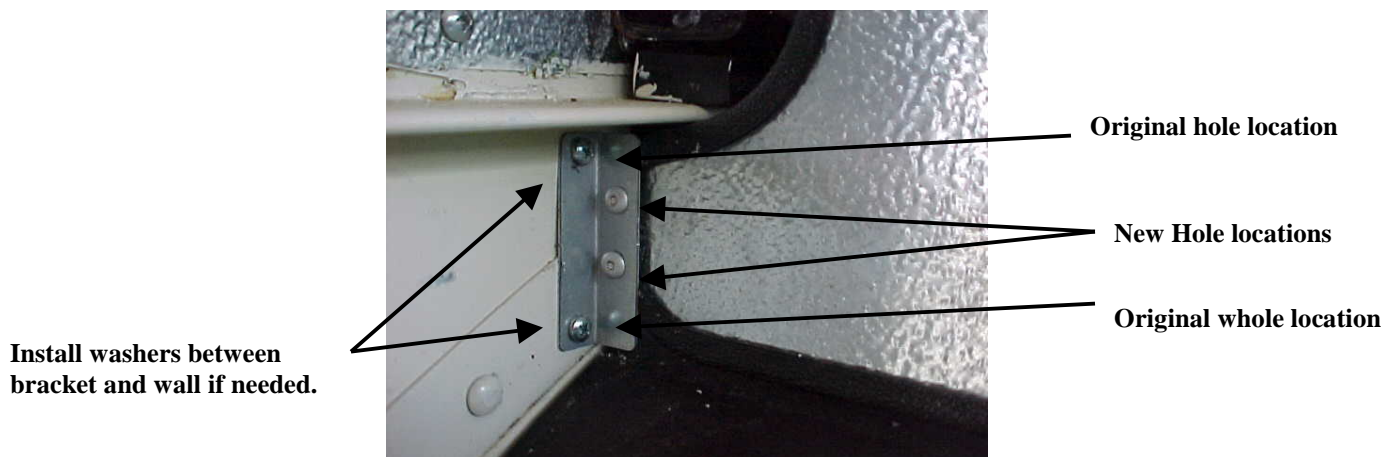
The original recall letter omitted the repair method with a special condition on the right side (entrance door side) modesty panel. The modesty panel at the wall sometimes is too short in height where it attaches to the new bracket at the wall. The two guide holes do not line-up with the panel and therefore you cannot attach the panel to the bracket. If the modesty panel at this area is not long enough in height to match the repair bracket predrilled guide holes, drilling one or two 1/8-inch diameter hole(s) closer to the center of the bracket and through the modesty panel to rivet the two parts together is permissible. The function of the bracket is to prevent the modesty panel from being kicked out of position and the closer location or one fastener will provide this function. Also the location of the existing rivets on the wall in the area varies and may interfere with the installation of the bracket in the desired position. Putting large diameter flat washers with a 3/16" to 1/4" inch hole as a spacer between the supplied bracket and the wall will move the bracket away from the existing rivet and provide an approved installation. The picture below shows the method of installing this bracket with the two rivets closer to the center of the bracket. If snake rubber is on the panels in the area it does not have to be trimmed back to clear the bracket. The rivet when installed will pull the panel as tight as needed.

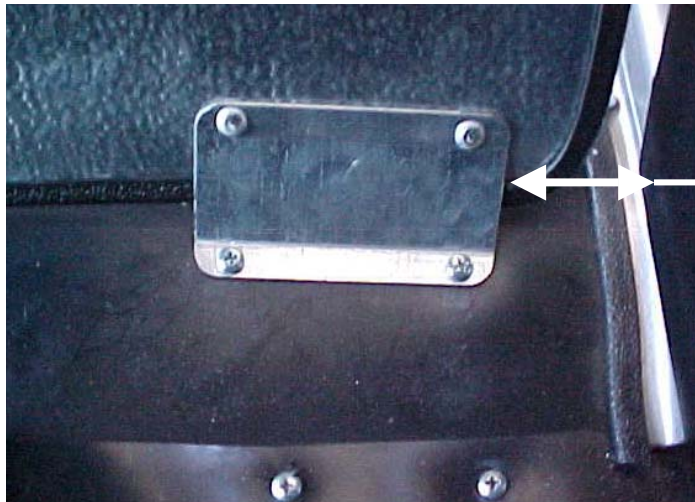
The original recall letter omitted the repair method and parts for a combination of the left modesty panel and drivers under seat heater, code 048PLX. The bracket supplied with the kit for this combination will not provide the proper repair and should not be used. In place of the bracket supplied with the kit, a new bracket part number 2209386C1 must be used. It mounts in a different location using the same size mounting hardware supplied with the kit and same size drill. When ordering a kit for units with this combination the new bracket must also be ordered. The picture below shows the proper method of installing this new bracket. This does not affect the repair of the right side modesty panel.

Position the bracket approximately 1.5 inches from the vertical face of the heater cover with the greater angle (about 45 degrees) attached to the modesty panel. For ease of installation, attach the bracket to the floor first with the upper portion in line with the modesty panel.

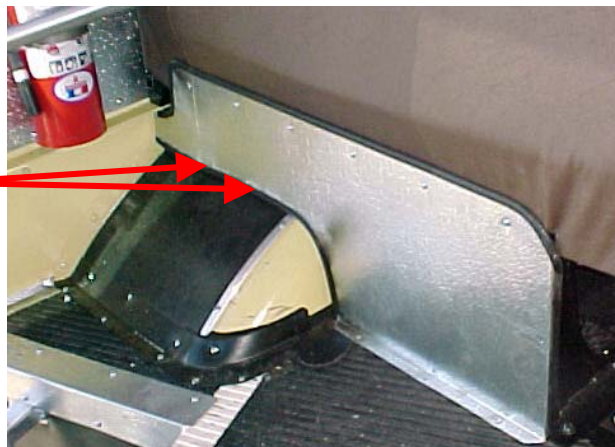
The steel modesty panel that is installed under the seat barrier behind the driver seat and behind the entrance door is cutout to clear the wheel well. This cutout allows the lower portion of the panel to be bent out of position leaving a gap between the wheel-well and the lower edge of the modesty panel at the cutout area. The edge of the cut out is protected with snake rubber (protective edging). If the snake rubber is knocked off of the edge of the panel, a raw edge is exposed facing down.

Area where  
panel may be  
bent out of  
position.

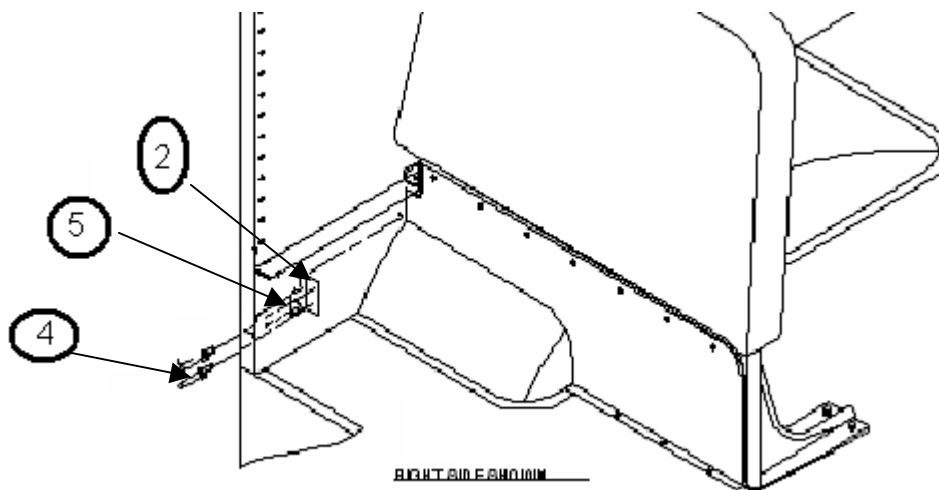
This repair procedure involves adding a bracket at the wall to secure the end of the modesty panel. This must be done to the panel on both sides of the bus.

1. Locate the angle (item #2) centered vertically with the end of the panel.
2. Install angle onto wall with two self-drilling screws (item #5).
3. Using a 1/8-inch drill bit, drill two holes through the angle and modesty panel.
4. Fasten angle to modesty panel with two (2) of item #4 –(rivet, pop 1/8")
