# Authorized Field Change

**AFC G-01905**

**Subject:** Replacement Headlamp Assemblies for 4300 and 4400 Models Built Between October 24, 2000 and February 7, 2001

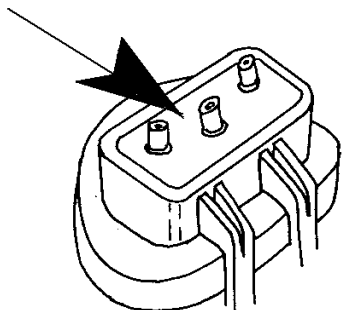
Figure 1 Headlamp Connector Seal

When installing the bulb connector to the headlamp assembly, the blades of the bulb terminals may have poor electrical contact with the harness connector resulting in heat build up and distortion of the connector body. Proper headlamp operation may be noted, however, progressive damage may occur with subsequent loss of headlamp illumination.

- B. If the harness connector body is colored black with a dark blue seal (see arrow in Figure 1), the headlamp assembly must be replaced. Proceed to the Service Procedure.

DARK BLUE SEAL
