TSI-03-13-05

Subject: Eaton Twin Countershaft Transmission Failures Caused by Incorrect Installation of Auxiliary Section

TMIB-0139

Topic: Proper Dowel Pin Location

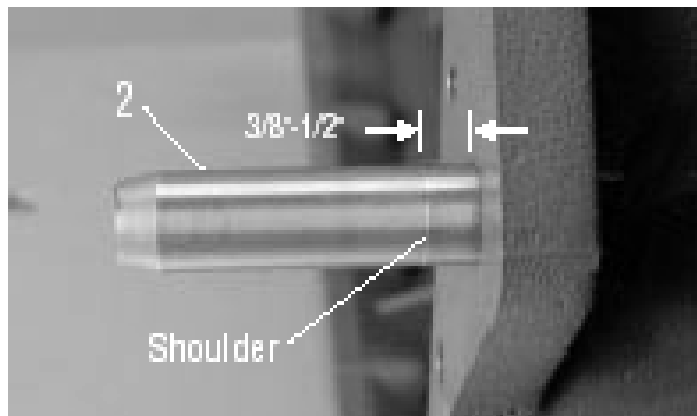
Transmission failures caused by incorrect auxiliary section installation. When installing the auxiliary section it is critical the dowel pins are in the proper location, failure to do so can cause various complaints including worn synchronizers, slow range/splitter shift and gear wear due to timing error.

The dowel pins must be properly installed prior to installing the auxiliary section. Please see Figure 1 for proper dowel pin installation. 3/8"-1/2" of pilot diameter must be exposed to rear of main case surface. Pilot diameter of dowel pin is .748" - .750".

Never tighten auxiliary section fasteners before installing dowel pins in proper location!
