Technical Service Information

TSI-04-13-02

Subject: New Fault Code 92 for Eaton AutoShift Transmission with System Controller Version 800, 801, or Greater

TAIB-0805

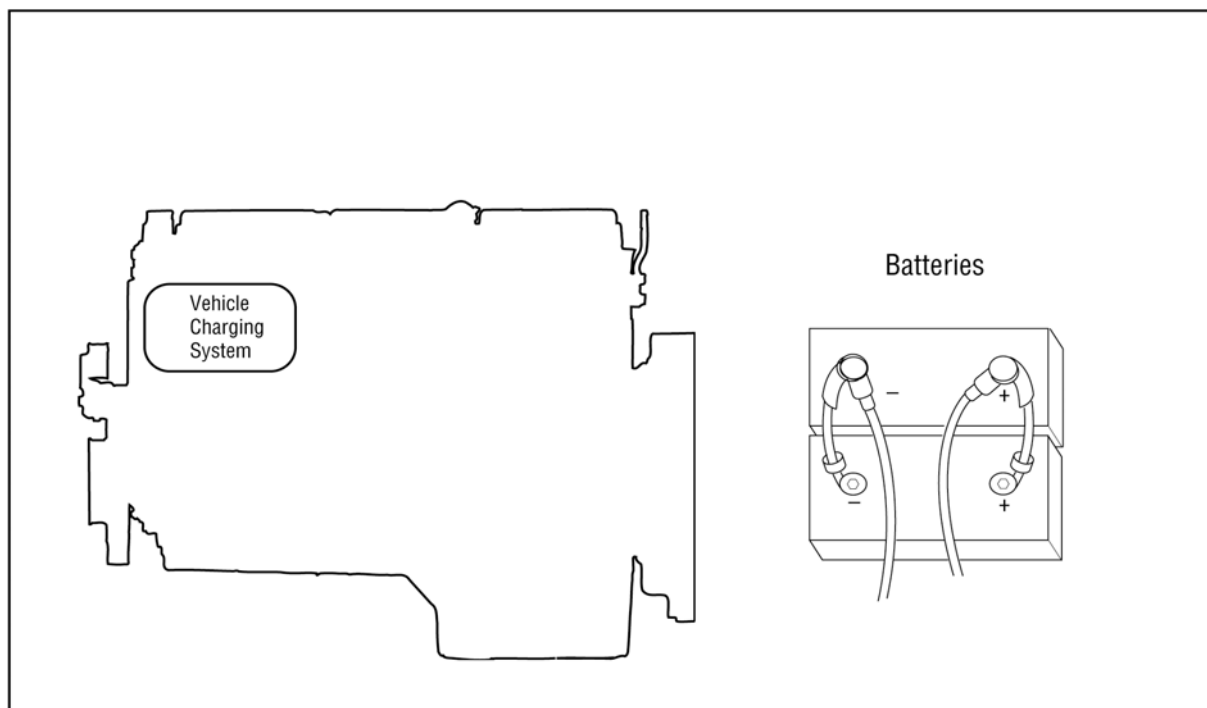
This fault code indicates that the vehicle is supplying weak battery voltage to the transmission.

Possible Causes

This fault code can be caused by any of the following:
Vehicle charging system or battery integrity
