IC Corporation

NON-COMPLIANCE RECALL 06505

September, 2006

Bottom Davenport
Panel to Floor RE
Joint

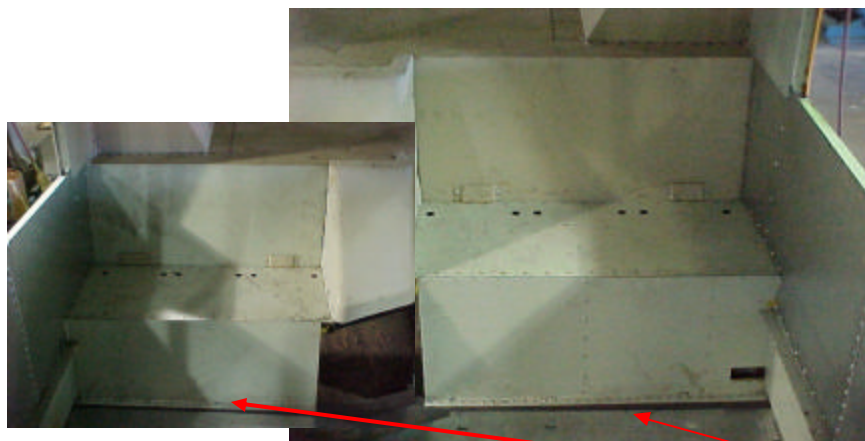
The joint where the davenport meets the bus floor may not meet the required minimum joint strength. This has been determined to be noncompliant with FMVSS 221 (571.221 S5.1, 5.1.1, S6.2).

In the event of a vehicle crash, the defective joint may result in a lack of structural integrity, possibly resulting in an injury or death to the vehicle occupants.

This repair involves securing three flat retaining bars along the front of the davenport joint. The retaining bars are secured with 1 1/2" screws spaced at 1 1/8" installed through the floor covering, plywood (if applicable), the davenport closeout's lower flange, and into the floor's substructure. The davenport closeout's lower flange is typically not visible beneath the floor mat and plywood (if applicable). There is only one part number for one length of retaining bar. The two shorter retaining bars are made by cutting the longer bar to the appropriate length.
