Authorized Field Change

AFC G-07917

Subject: Aftertreatment Calibration and Enhanced Diagnosis

Engine Family: MaxxForce DT, 9 and 10

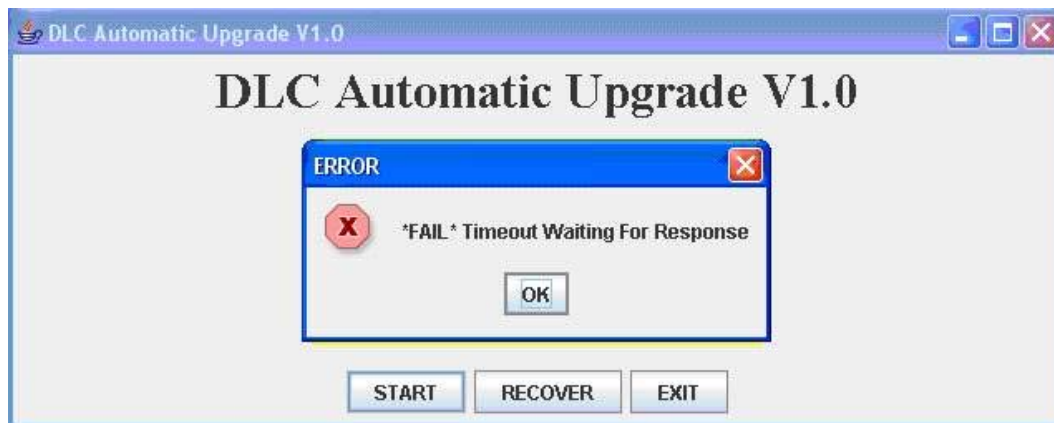
NOTE – If there is an error during programming you will have to fix the problem (i.e.; battery voltage, cable is accidentally disconnected, laptop's battery is low and the laptop turns off, etc.) select the VIN.exe file in the recover menu.

Figure 13 Example of Error

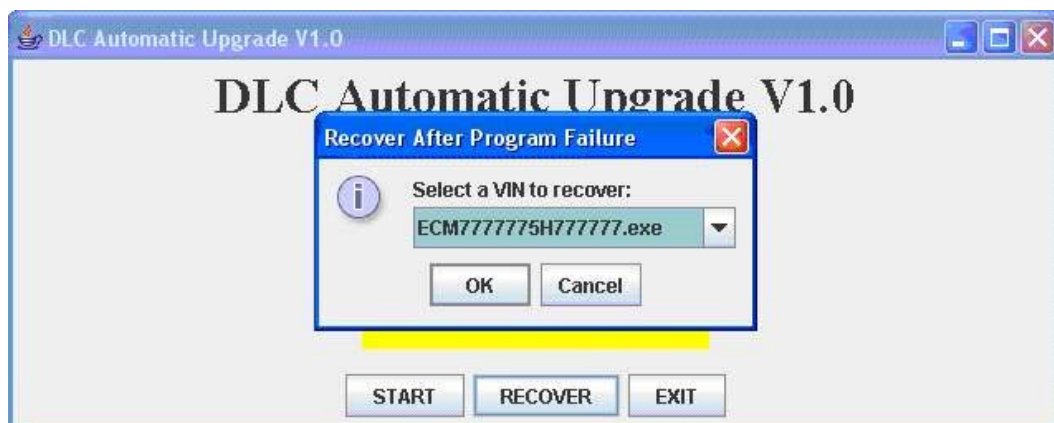
Figure 14 Select the VIN.exe and press OK
