# VEHICLE RECALL

**G-02501**  
**March, 2002**

**SUBJECT:      VEHICLE RECALL (U.S., EXPORT)**  
**Under-Torqued Mounting Bolts on International**  
**Ride Optimized Air Suspensions (IROS) on 4300 &**  
**4400 Models Built from 10/24/00 through 10/30/01.**

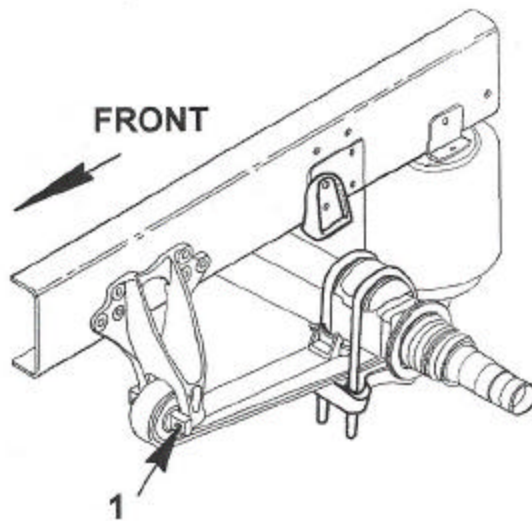
**Figure 1: Driver's Side View of IROS Suspension**

There is a right and left main support member on the IROS rear suspension that mounts between the air spring, main support member frame hanger bracket, and the axle (see Figure 1, page 2). The function of the main support members is to provide support and location for the axle. Two bolts and nuts hold the ends of the bar pin, found in each main support member end bushing, to the frame mounted main support member hanger. During assembly, those bolts and nuts were not tightened to the required torque specification of 500 to 625 NM.

With less than the specified clamp load, the nuts can become loose and un-thread completely, or the bolts could fracture from fatigue. Either of these conditions could cause the connection to fail during the life of the vehicle which could result in a sudden loss of control of the vehicle and possibly a vehicular accident, property damage, or personal injury or death.

1. Bolts go through the bushing bar pin in the direction of the arrow with the bolt head against the bar pin and the nut against the hanger. There are two bolts and two nuts required per side.

**INTRODUCTION:** Replace all four bolts and nuts on all vehicles in this campaign. There is no inspection option for this Safety Recall. Use one kit (8900081R91) per vehicle, which contains four locking nuts and four bolts. See Figure 1 below.

3. Shut off the engine and apply the parking brakes.
4. Remove one bolt and nut at a time then install a new bolt and nut and tighten the new bolt almost to full torque so that the clamp load will hold the bushing pin aligned while the other bolt is replaced. Repeat this step until all four bolts and nuts have been replaced. The new bolts and nuts must be installed with the nuts facing the rear. **DO NOT REUSE ANY OF THE ORIGINAL BOLTS OR NUTS** because they may not hold torque.

5. Tighten the new bolts and nuts to 370-460 **Lbf-Ft** (500-625 NM) with a torque wrench.
6. Immediately scrap the original equipment nuts and bolts that were just removed.
