IC Corporation

SAFETY RECALL 05508

August 2005

Recall Campaign #05508 & SUBJECT (RE Driveline with IROS)

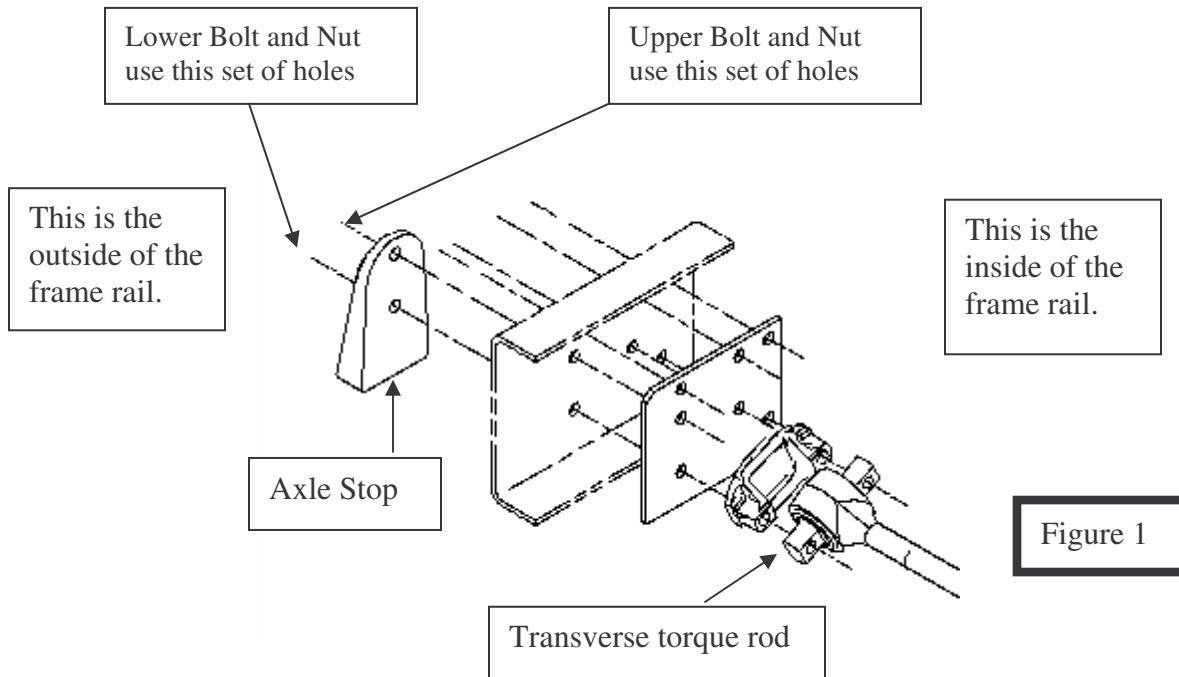
The axle stops are held to the frame rail by 2 sets of bolts and nuts that pass through the frame rail. **Right side** is shown in Figure 1 below. The proper position of the bolts and nuts is to place the bolts into the holes from the inside, so that the nuts are on the outside of the frame rail. This correct position allows sufficient access to the nuts for the torque operation.

1. Remove Upper Nut and Upper Bolt that holds axle stop to frame rail.
2. Remove Lower Nut and Lower Bolt that holds axle stop to frame rail.
3. Replace axle stop with new one.
4. Replace the axle stop bolts and nuts with the **new** bolts and nuts that are included in the kit. Both bolts for the left side are the same length.
5. Torque the axle stop nuts to **between 196 and 239 LbF-Ft** (266-324 Nm).

1. Remove Upper Nut and Upper Bolt that holds axle stop to frame rail.
2. Remove Lower Nut and Lower Bolt that holds axle stop and transverse torque rod to frame rail.
3. Replace the axle stop bolts and nuts with the **new** bolts and nuts that are included in the kit. Both bolts for the right side are **NOT** the same length. Use the **longer** bolt to replace the Lower Bolt that also holds the transverse torque rod to the frame.
4. Torque the axle stop nuts to **between 196 and 239 LbF-Ft** (266-324 Nm).
