Authorized Field Change

AFC G-02908

Subject: 9200i, 9400i, and 9900i Models with Cummins ISX Engines and Leece Neville Starters, International Codes 08WWM and 08WTB, Built at Escobedo Before August 27, 2002 and at Chatham Before August 29, 2002 have Incorrect Starter Nose Cone Housings

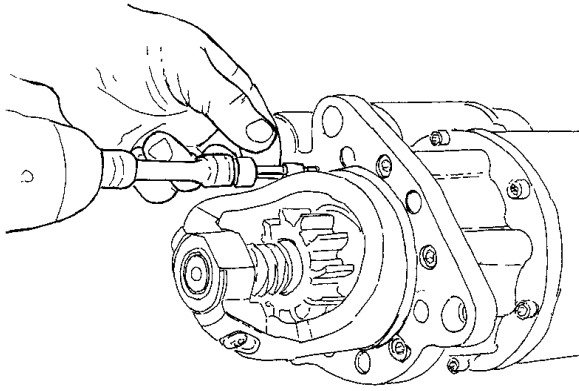
Figure 1 Remove Starter Motor Nose Cone Housing

1. Disconnect the negative cable from the battery.
2. Disconnect power and ground cables from the starter motor.
3. Remove starter motor mounting bolts and remove starter.
4. Place the starter motor on a work bench and remove the nose cone housing mounting bolts (Figure 1) .

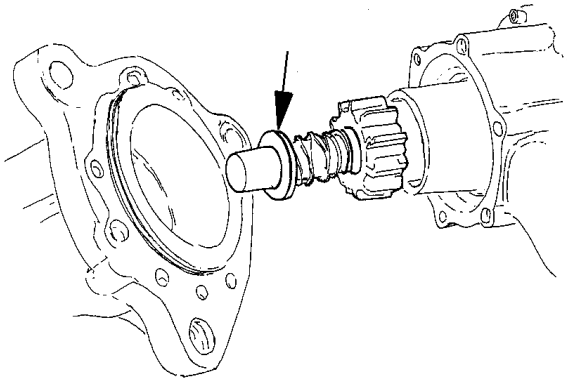
Figure 2 Verify Washer is on the Shaft (Arrow)

5. Remove the nose cone Housing. Verify the washer is still on the shaft (Figure 2).

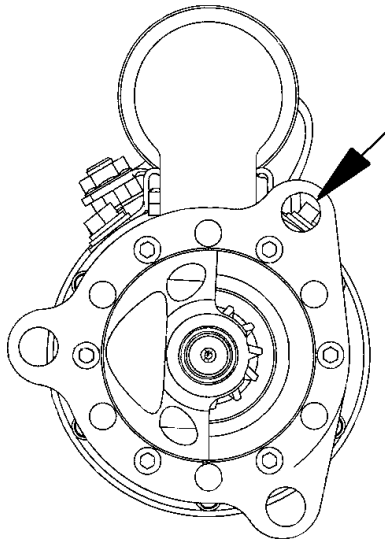
Figure 3 Flange Mounting Hole (Arrow) Aligned with Solenoid Housing Mounting Bolt Shown in the Background When Viewed Through the Flange Mounting Hole

6. Install the new nose cone housing. Align the flange as shown in Figure 3. When the nose cone housing flange is correctly aligned, the flange mounting hole, arrow in Figure 3 , will be approximately in line with the solenoid housing mounting bolt. Placing a screwdriver through the flange hole in line with the solenoid mounting bolt (Figure 4) may be helpful to guide to align the nose cone housing flange.

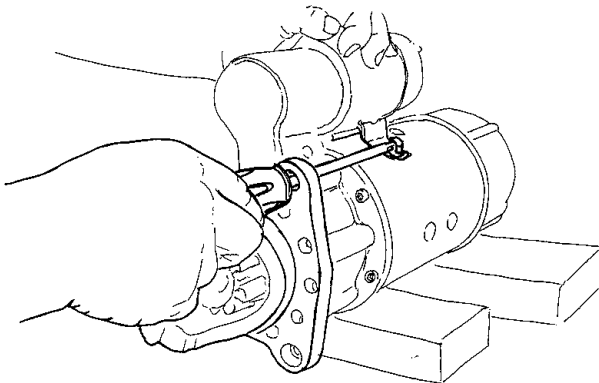
Figure 4 Using a Screwdriver to Align Flange Mounting Hole with Solenoid Housing Mounting Bolt

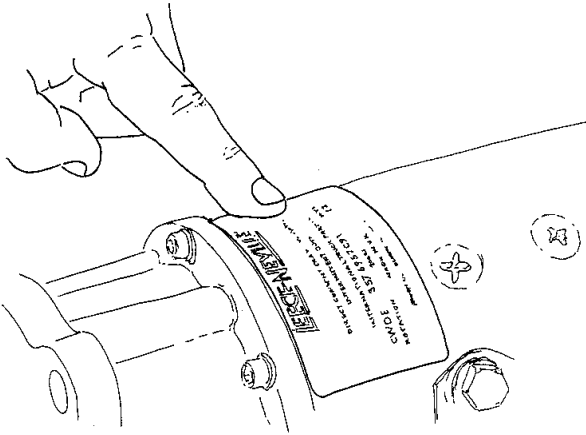
Figure 5 Attach New ID Label

7. Apply Loc-Tite 242 to the nose cone housing mounting bolts and tighten to 25 Lbf-ft (34 Nm).
8. Verify the starter motor is free to rotate counter clockwise.
9. Remove the starter identification label and replace with a new label from the service kit. Refer to Table 2 for the correct label to use for the starter motor being serviced (Figure 5).

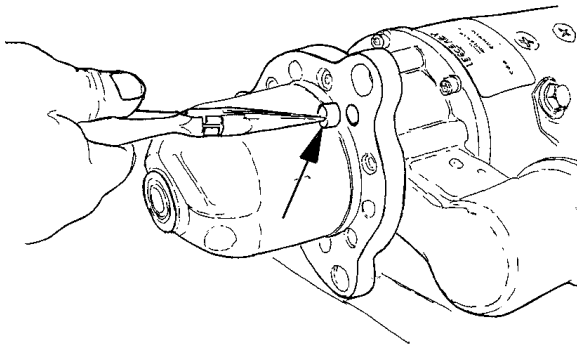
Figure 6 Installing Rubber Seals (Arrow)

10. Remove the rubber seals from the old nose cone and install into the unused bolt holes in the new nose cone (Figure 6).
