VEHICLE RECALL

G-01510 ADDENDUM

SUBJECT: VEHICLE RECALL (U.S., EXPORT)
TRW Tie Rod Ends on Certain 2000, 4000,
5000, 8000 and 9000 model series built from
6/15/1999 through 8/15/2000.

G-01510
August, 2001

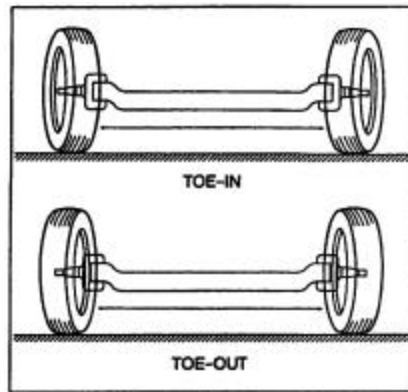
Figure 1: Viewed From The Front Of The Vehicle

TOE-IN PROCEDURE: If electronic equipment is not available, the following procedure may be used to set toe-in (see pages 3 and 4). To obtain an accurate reading, two trained technicians are required to insure that the pointers are always placed or adjusted to be exactly in front of the line scribed on both tires. Toe-in is the amount in fractions of an inch that the front wheels are closer together at the front than at the back (Figure 1, on the next page).
