Authorized Field Change

AFC G-06920

Subject: Transmission Clean Power and Ground Rewire

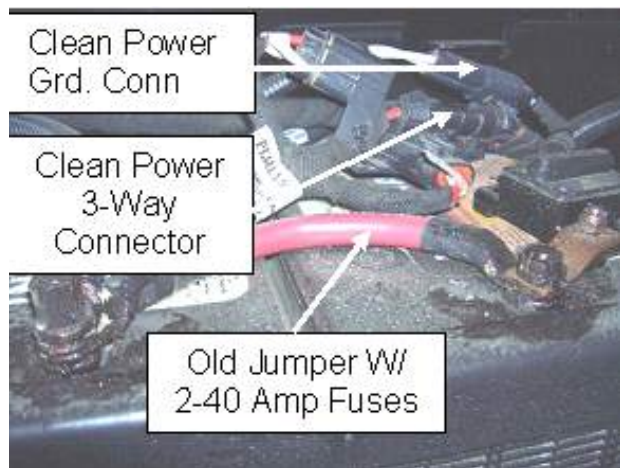
Figure 1

2. Unplug the 3-way connector from the positive clean power harness and the 2-way clean power ground connector in the battery box. See Figure 1.

3. Remove the clean power jumper cable from the positive battery terminal(s). See Figure 1.
4. Install the new 3-way clean power harness and jumper (8000888R91) shown in Figure 2 to the battery positive terminals. Make sure the new jumper cable/harness has two 40 amp fuses and the TRANS ECU FEED CONN has a 30 amp fuse.
5. Locate the transmission 24-way 4705 connector located between the engine valve cover and the steering column as shown in Figure 3. The correct connector half will have Circuit J14AW (red) in cavity 13.
