VEHICLE RECALL

INTERIM ACTION G-04521

February 2005

**SUBJECT: INTERIM ACTION SAFETY RECALL (U.S., EXPORT)
CAB MOUNTS on certain 4000, 7000, and 8000
Series Models built 1/16/2004 thru 11/1/2004**

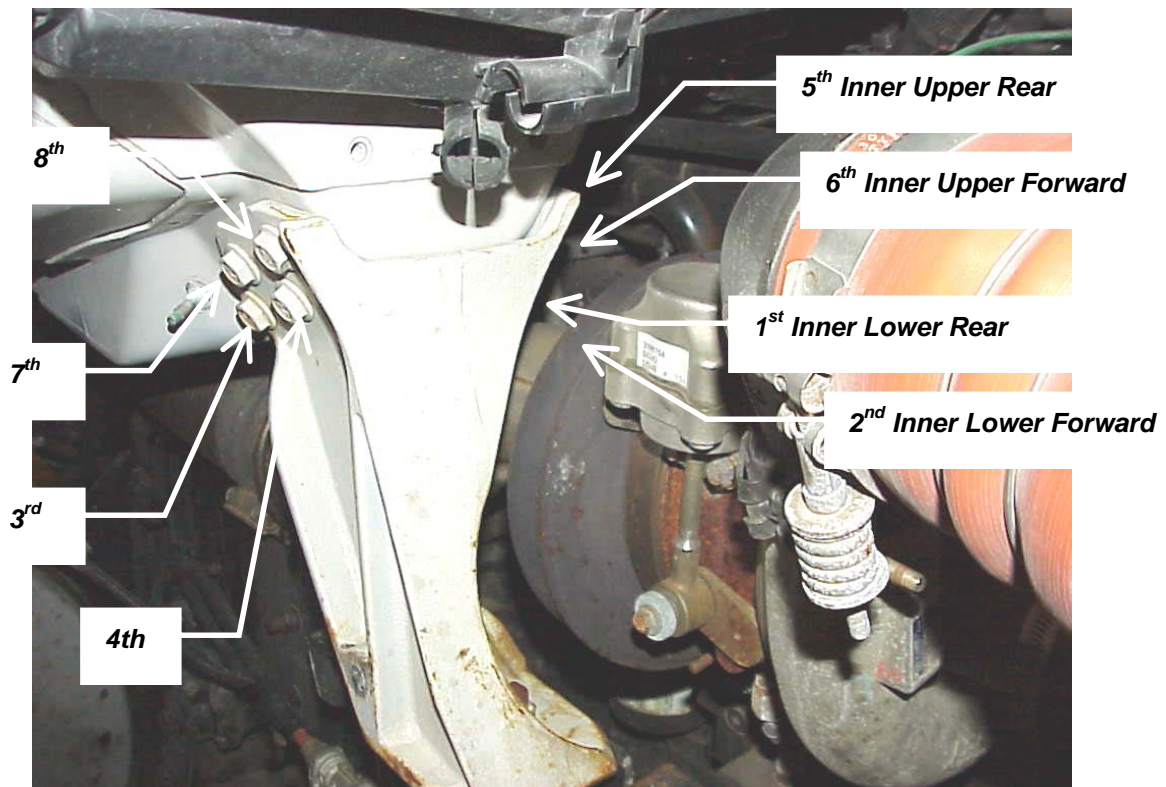
Figure 1 – Bolt Torque Pattern

1. Remove the Fender Extensions. Mid-High mounted cabs (4400, 7300, 7400, 7500, 8500) will have three (3) fasteners attaching each fender extension while High mounted cabs (7600, 7700, 8600) will have four (4) fasteners for each fender extension.
2. While following the Bolt Torque Pattern defined below, tighten **ONE** cab mounting bolt at a time. Torque bolt to **115-120 LbF-Ft (156-163 Nm)**.
3. Repeat step 2 until all sixteen (16) cab mounting bolts are properly torqued.
4. Replace and torque missing bolts as necessary.
5. Reinstall the fender extensions.
6. Refer to the following figures for more information:

<i>Bolt Torque Pattern per Side</i>	<i>Cab Mount Bolt Location</i>
1 st	Lower, Inner, Rear
2 nd	Lower, Inner, Forward
3 rd	Lower, Outer, Rear
4 th	Lower Outer, Forward
5 th	Upper, Inner Rear
6 th	Upper, Inner, Forward
7 th	Upper, Outer, Rear
8 th	Upper, Outer, Forward

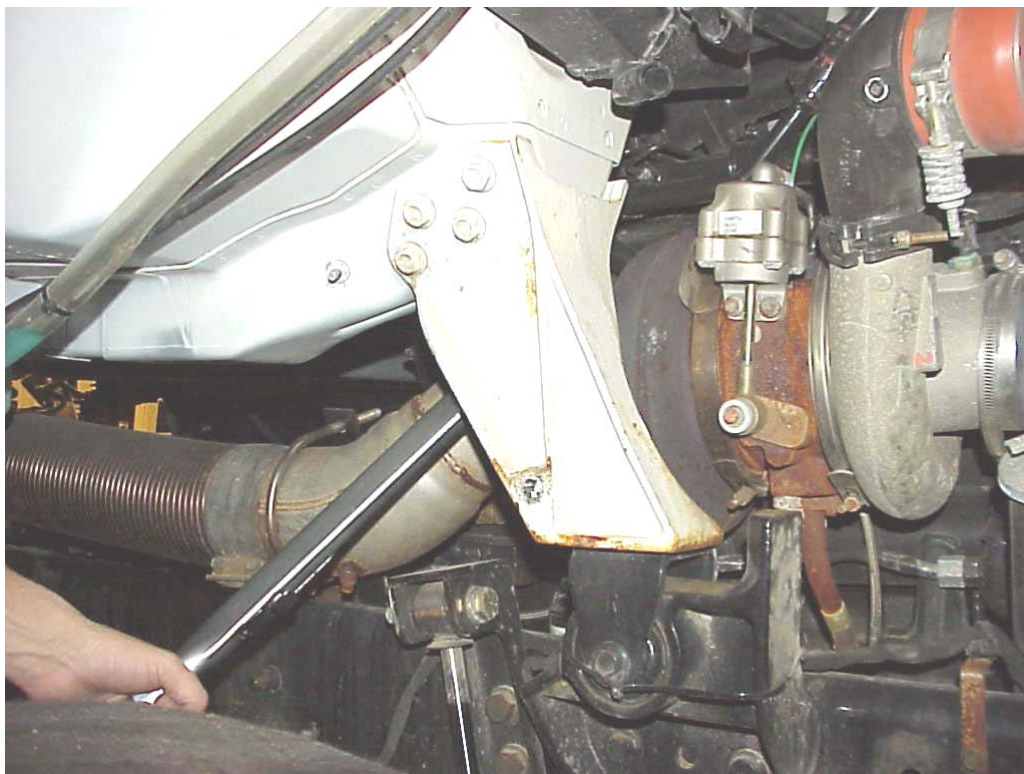
**Figure 2 – Access Inner Bolts from Under and Behind Mounts
(Passenger Side Shown)**

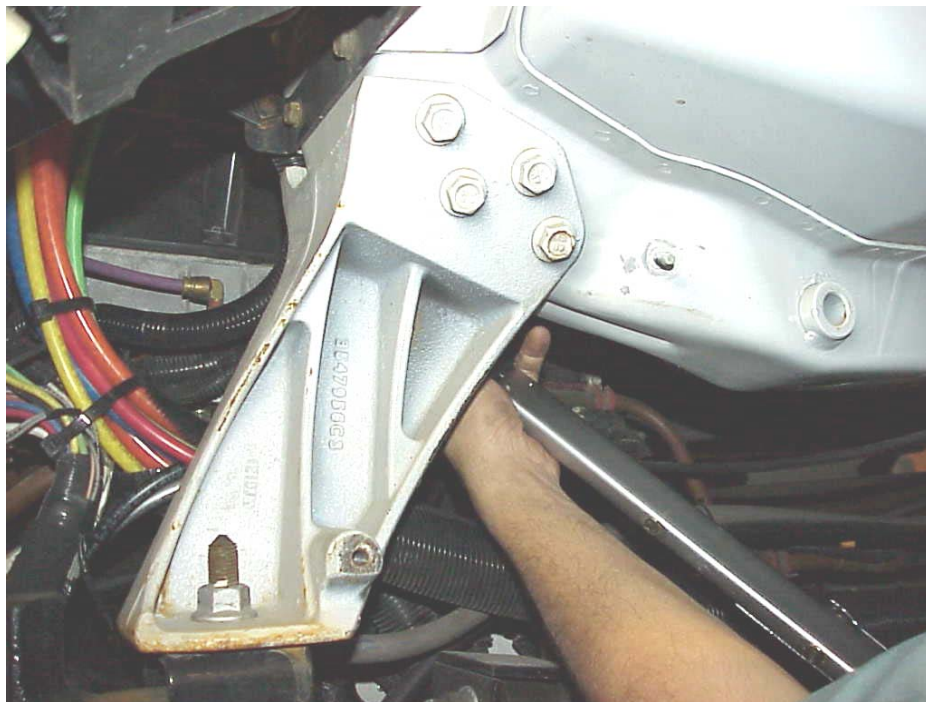
**Figure 3 – Access Inner Bolts from Under and Behind Mounts
(Driver's Side Shown)**

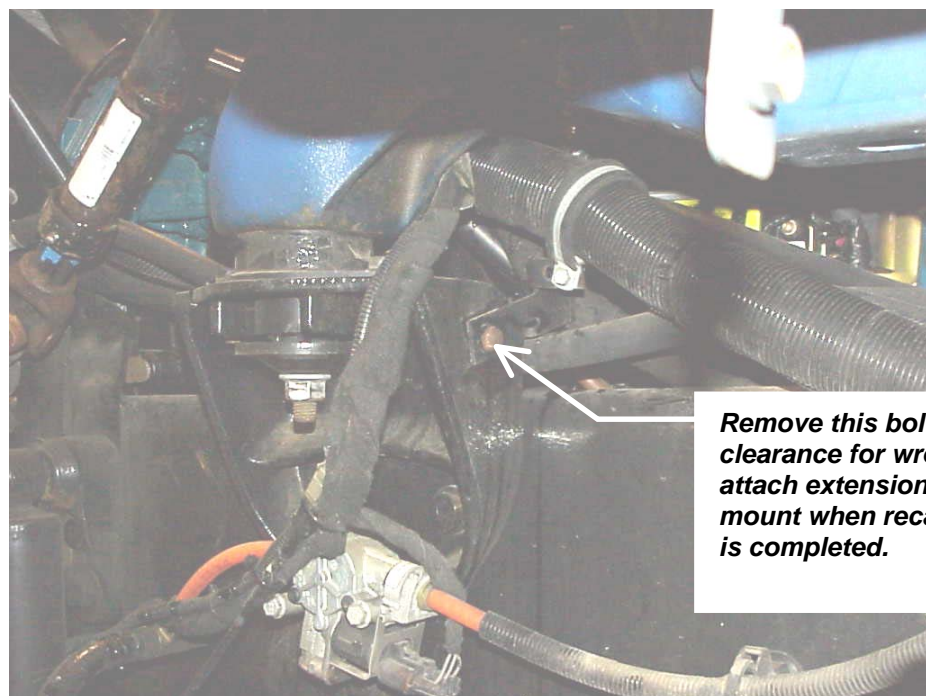
Figure 4 – You may need to remove extension clip as indicated for torque wrench clearance. *This is on Mid-Mount Cabs ONLY.*
