Authorized Field Change

AFC 02903

Subject: New Windshield Washer Solvent Reservoir for 73/74/7500 and 8500 Models Built Between May 28, 2001 and February 27, 2002

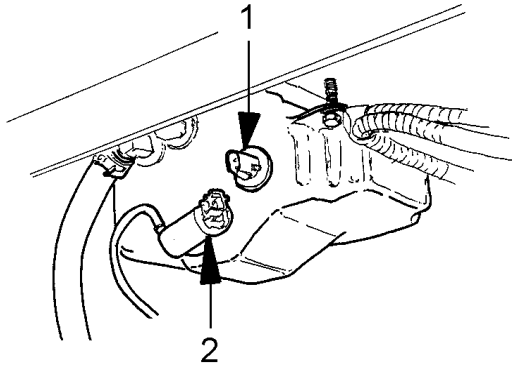
Figure 2 Washer Reservoir Pump and Sensor

1. FLUID LEVEL SENSOR
2. WASHER RESERVOIR PUMP

2. Disconnect the harness connectors from the windshield washer pump and fluid level sensor (Figure 2).

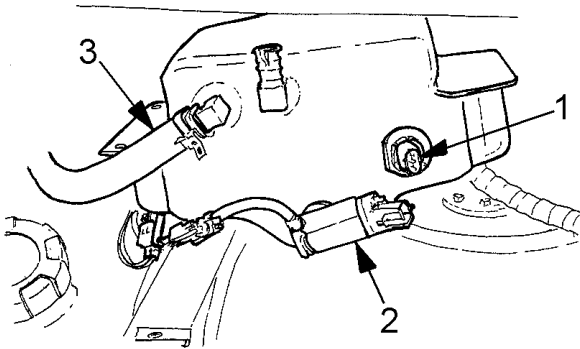
Figure 4 Remove Pump with Hose Attached

- 1. FLUID LEVEL SENSOR
- 2. WASHER RESERVOIR PUMP
- 3. WASHER RESERVOIR FILL HOSE

5. Remove the washer reservoir pump and hose (do not remove the hose from the pump)(Figure 4).

- 6. Remove the washer reservoir fill hose (Figure 4, Item 3).
- 7. Drain the windshield fluid from the washer reservoir into a clean container for reuse.
- 8. Remove the fluid level sensor for reuse in the new reservoir (Figure 4, Item 1).
- 9. Install the fluid level sensor into the new washer reservoir. The sensor must be oriented so that the flat on the sensor (Figure 5) aligns with the flat line molded on the washer reservoir (Figure 6).

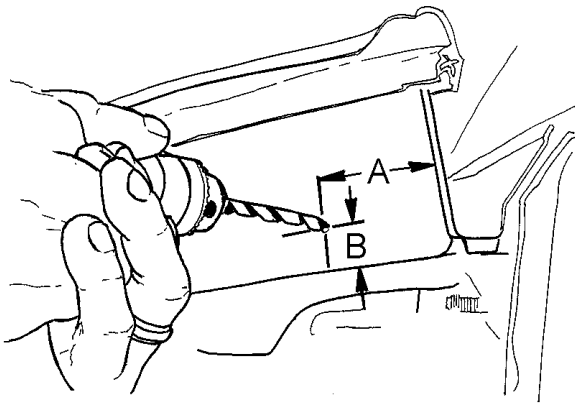
Figure 7 Drill Hole in Cowl Tray

- A. 4 INCHES (100 MM)
- B. 1 INCH (25 MM)

10. Locate and drill a 1/4 inch hole in the cowl tray that is 1 inch (25 MM) vertical from the bottom edge of the cowl tray (Figure 7, Item B) and 4 inches (100 MM) from the edge of the cowl tray on the drivers side of the vehicle (Figure 7, Item A).
