RECALL NOTICE

**IC CORPORATION RECALL # 04305
NHTSA RECALL # 04V-498**

30-Inch Child Restraint Seat Cushion Retention

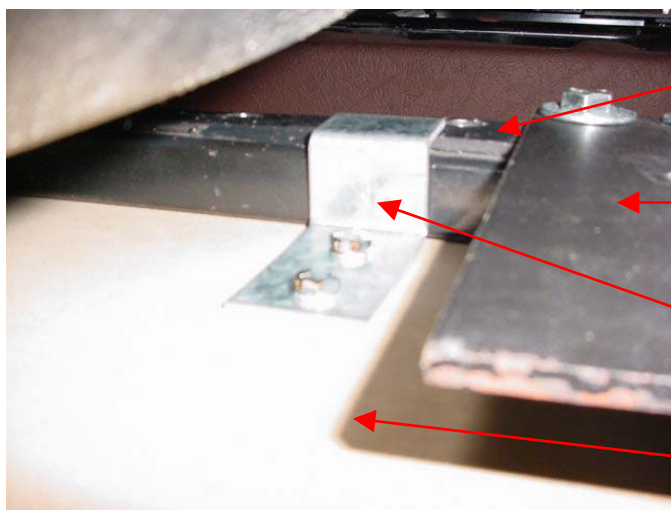
Rectangular support is located in rear portion of seat cushion frame.

Reinforcement on aisle side of seat frame.

Z-shaped clip installed approximately 1-inch from reinforcement plate.

Under side of seat cushion.

1. Make sure that the cushion is in place and snug against the sidewall of the bus.
2. Using the metal Z-shaped clip, hold in place against the rectangular rear longitudinal bar and the board on the bottom side of the seat cushion. Leave about 1-inch between edge of clip and seat frame reinforcement plate.

11. Return seat to the proper position, which requires the seat cushion to be tight against the wall of the bus.
12. Using two (2) 1/4-inch bolts with 1/4-inch lock washers, secure the z-shaped clip to the board using the T-nuts just installed. These bolts must be inserted into the nut insert that was just installed.
