Technical Service Information

TSI-04-13-03

Subject: New Fault Code 93 for Eaton AutoShift Transmission with System Controller Version 800, 801, or Greater

TAIB-0806

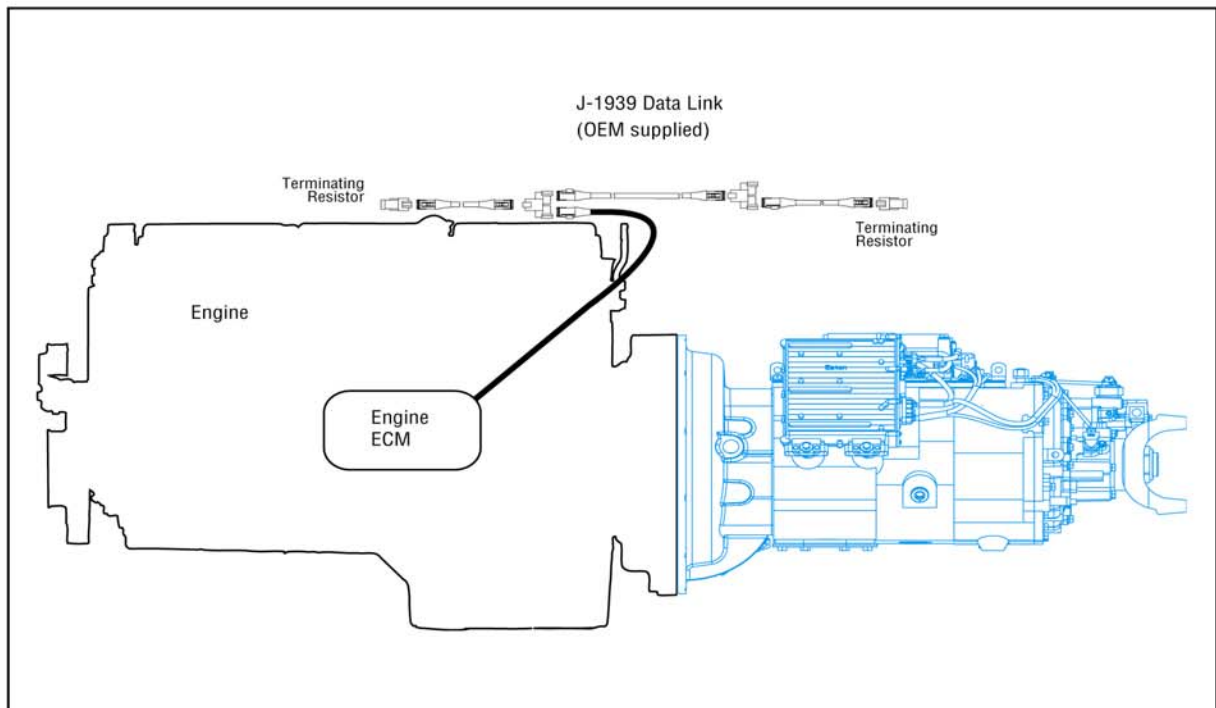
This fault code indicates the System Controller is broadcasting J-1939 messages and receiving J-1939 messages, but has not received J-1939 messages from the engine.

The fault is detected if J-1939 communication from the engine is lost for 5 seconds.

If the fault occurs while moving, it causes a 1-speed fallback. Once vehicle has stopped, the starting gear and reverse can be engaged. If the failure occurs at system initialization, it causes an AutoSelect fallback mode.

- OEM supplied J-1939 harness
- Engine ECM

Step A	Procedure	Condition	Action
	1. Key on.		
	2. If fault code 93 is present, inactive or active.		
	3. Inspect OEM J-1939 harness.		
		If problem found	Repair OEM J-1939 harness. Go to Step V .
		If no problem is found	Go to Step V .

Step V	Procedure	Condition	Action
	1. Key off.		
	2. Reconnect all connectors.		
	3. Key on.		
	4. Clear codes (see page 1-3).		
	5. Use Driving Techniques to attempt to reset the code (see page 1-4).		
	6. Check for codes (see page 1-3).	If no codes	Test complete.
		If code 93 appears	Return to Step A to find error in testing.
		If code other than 93 appears	Go to Fault Code Isolation Procedure Index (see page 1-9).
