# Authorized Field Change

**AFC G-03907**

**Subject:** The Hood Lower Hinge Bolts May Contact the Air Conditioning Lines in 7600 SBA Models Built at the Garland Assembly Plant before July 25, 2003

Truck Model: 7600SBA

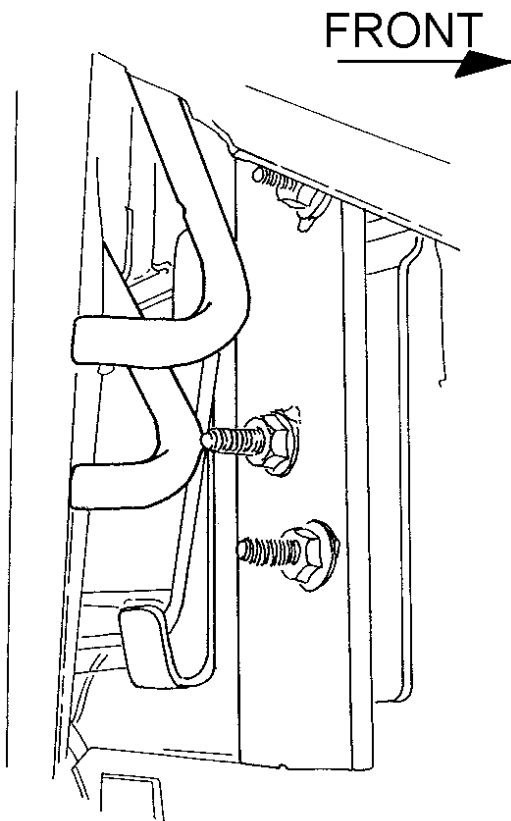
In some cases the hood lower hinge mounting bolts, on the passenger side, may contact the air conditioning lines (Figure 1) in 7600SBA Models built at the Garland Assembly Plant before July 25, 2003. This contact may cause the air conditioning lines to fail.

Figure 1 Lower Hood Hinge Bolts As Viewed From The Passenger Side

Effective July 25, 2003 a new bolt, Part Number 35715000C1, is used in production.

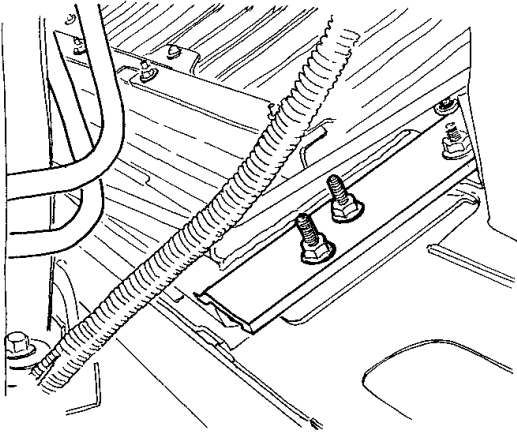
1. Open the hood and locate the two lower hinge bolts. Inspect the air conditioning lines for bolt contact. If no contact is noted and there is a minimum of 6 mm (1/4 inch) clearance, this procedure is not necessary. If inadequate clearance or bolt contact with the air conditioning lines is noted, proceed to the next Step.

**Figure 2 Lower Hood Hinge Bolts As Viewed With Hood Open**

2. Use an air tool with cut off wheel, or equivalent, to cut (shorten) the two (2) lower hood hinge mounting bolts 10 MM ( 3/8 inch). Make sure two (2) exposed threads remain on each bolt.
