# VEHICLE RECALL

G-02514  
September 2002

**SUBJECT: VEHICLE RECALL (U.S., EXPORT)  
INTERMEDIATE STEERING SHAFT PINCH BOLTS  
COULD BE MISSING OR LOOSE on 9200*i*, 9400*i*, and  
9900*i* models built at Escobedo from 6/4/02 through  
9/12/02.**

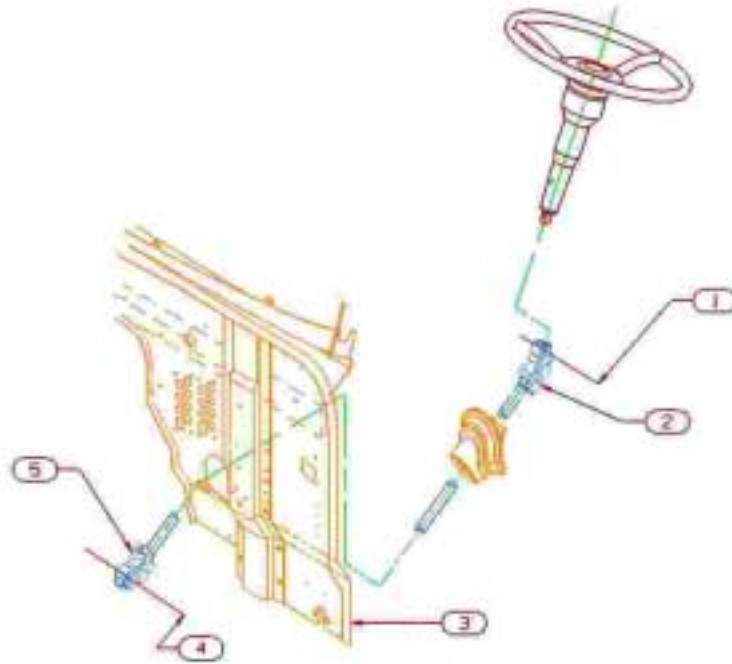
**Figure 1: Assembly View of Intermediate Steering Shaft**

The intermediate steering shaft connects the steering column to the steering gear box and is held in place by two pinch bolts. One pinch bolt is at the upper end of the intermediate shaft, inside the cab, and the second pinch bolt is at the lower end of the intermediate shaft, outside the cab, at the steering gear box. Both pinch bolts could be missing or loose. See Figure 1.

- Items:**
1. Upper pinch bolt at steering column
  2. Upper end of intermediate shaft
  3. Cowl or cab front panel
  4. Lower pinch bolt at steering gear
  5. Lower end of intermediate shaft

**DESCRIPTION:** All vehicles in this recall must have the intermediate steering shaft inspected to make sure the pinch bolts **AT BOTH ENDS** are installed and have the proper torque applied to the bolts. The upper end of the intermediate shaft is inside the cab and the lower end is outside the cab and connects to the steering gear. See Figure 1.

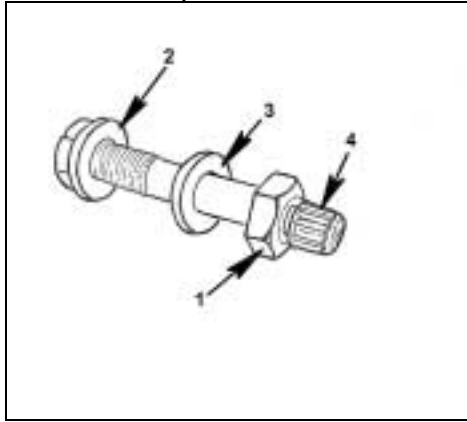
**Figure 2: Special Pinch Bolt**

- Items:**
1. Hex Head of pinch bolt
  2. Flanged nut
  3. Flat washer for under head of bolt
  4. Twist-off 12-point head on pinch bolt

3. Shut off the engine, apply the parking brake and put the transmission in neutral.
4. Some interior trim levels require removal of the lower cover, under the steering column, for access to the upper intermediate steering shaft u-joint pinch bolt. If necessary, remove this cover.
5. Locate the head of the pinch bolt and see if the 3/8" 12-point head (reference Figure 2, Item 4) has been properly twisted off, leaving an unpainted spot in the center of the bolt head. If the twist-off head is gone, no action is required for this pinch bolt. Proceed to step 8.

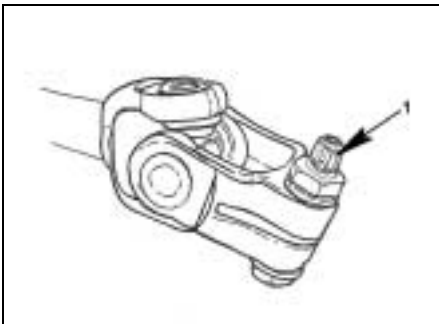
**Figure 3: Under-torqued Bolt**

**Item: 1.** Twist-off head has Not been properly tightened.

7. If the 3/8" 12-point twist-off bolt head is still attached to the bolt as shown in Figure 3, this indicates the bolt is not at the proper torque. Hold the nut and tighten the 3/8" 12-point bolt head until it snaps off of the hex head of the pinch bolt as shown in Figure 4. When the 12-point hex head snaps off, the bolt is properly torqued.
8. Under the hood, inspect the pinch bolt at the intermediate steering shaft coupler to the steering gear. Repeat steps 5, 6 and 7 for this bolt also.

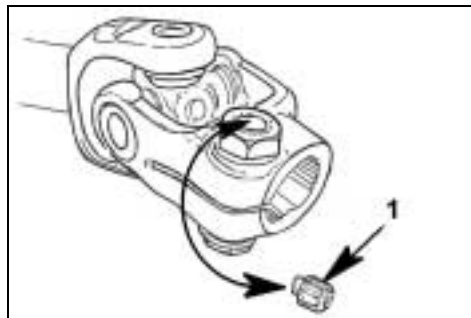
**Figure 4: Tightened Bolt**

**Item: 1.** Pinch bolt has been properly tightened when twist-off head breaks off.

6. If the bolt is missing, install the new bolt, hardened flat washer and nut as described in the following "PART INFORMATION" section. The washer must be positioned under the bolt head. Holding the nut, tighten the 12-point head on the bolt until the 3/8" head snaps off as shown in Figure 4. No further torque is required.
