# Authorized Field Change

**AFC 04905**

**Subject:** 9000i Models Built at the Escobedo Assembly Plant, Between August 1, 2002 and February 12, 2004, with Post 2002 Emission Cummins ISM Engines have the Heater Piping Mounting Bracket Mislocated on the Engine

Truck Model: 9000i

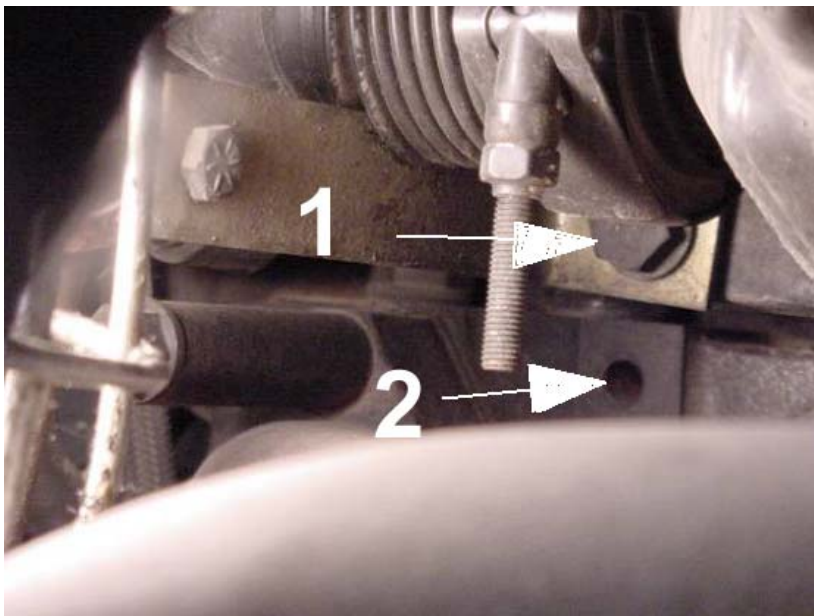
9000i Models built in Escobedo have the heater piping bracket mounted to the engine valve cover instead of the engine block. When the bracket is mounted to the engine valve cover, the bracket may contact the EGR pipe and may result in a failure of the EGR pipe bellows and exhaust leakage.

**Figure 1 Relocate Bracket to Hole 2**

1. Valve Cover Hole
2. Correct Hole in Engine Block

1. Locate the heater pipe mounting bracket (Figure 1), remove the mounting bolt and relocate the mounting bracket and mounting bolt to the lower hole as shown in Figure 1, Item 2.

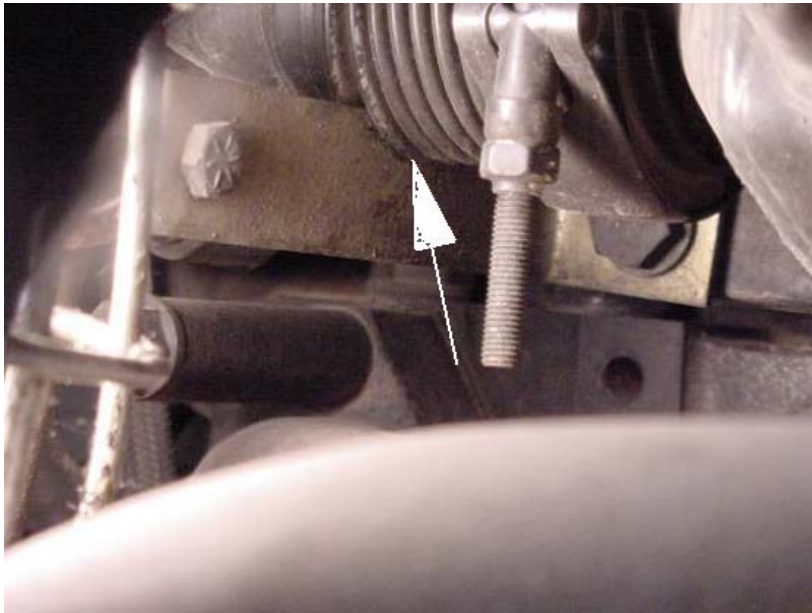
**Figure 2 EGR Connector Pipe Bellows Shown at Arrow**

2. Inspect the bellows of the EGR connector pipe for evidence of contact with the heater pipe bracket (Figure 2).
  - A. If there is no evidence of contact, the EGR connector tube does not need to be replaced.
  - B. If there is evidence of contact between the heater pipe bracket and the EGR connector pipe bellows, the EGR connect pipe needs to be replaced. Continue to the next Step.

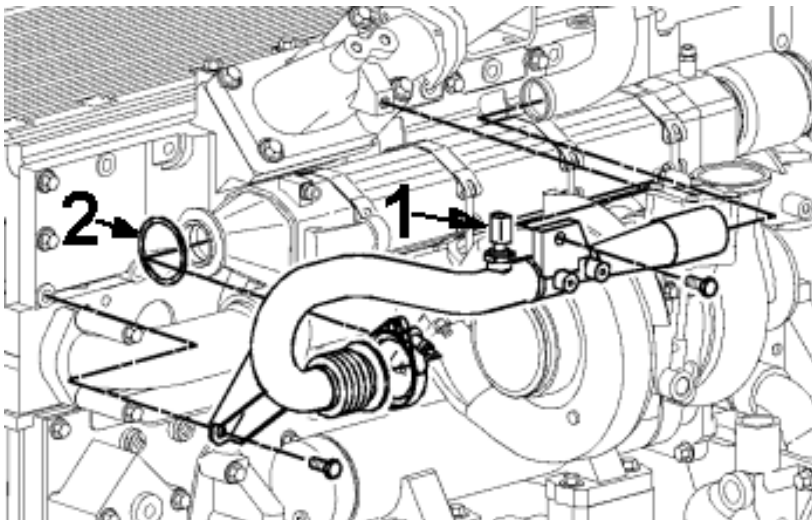
**Figure 3 EGR Connector Pipe Removal**

1. EGR Sensor
2. Seal

3. Remove the EGR connector pipe fasteners, clamps, sensor, seal, and EGR pipe as shown in Figure 3. Retain the fasteners, clamps, sensor, and seal for reuse.

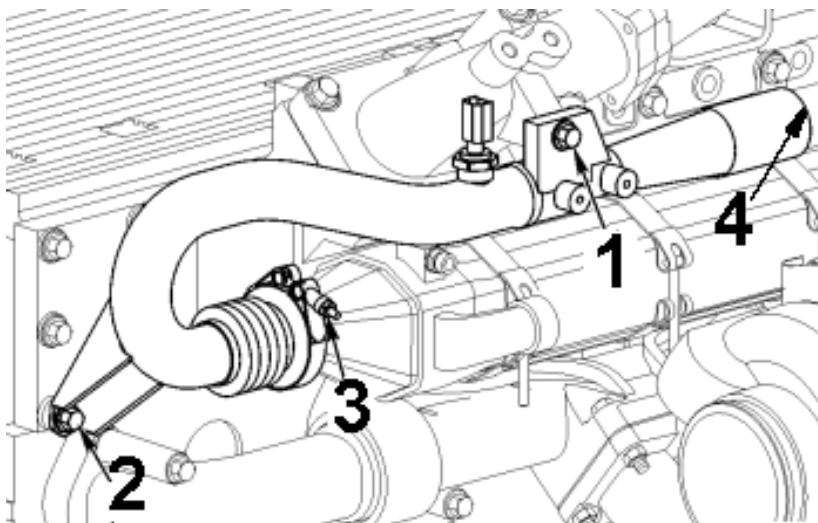
**Figure 4 Tighten Fasteners and Clamps**

1. Upper EGR Connector Pipe Cap Screw
2. Lower EGR Connector Pipe Cap Screw
3. V-Band
4. Clamp

4. Install new EGR Connector pipe. Refer to Figure 4 and Table 2.

Figure 4 Item Number	Torque Specification
1	32 to 39 Lbf-ft (43 to 53 Nm)
2	32 to 39 Lbf-ft (43 to 53 Nm)
3	135 to 165 Lbf-in (15 to 19 Nm)
4	54 to 75 Lbf-in (6 to 8 Nm)
