VEHICLE RECALL

G-04507
June 2004

SUBJECT: SAFETY RECALL (U.S., EXPORT)
Kelsey-Hayes (Lucas Varity or TRW) Anti-Lock Brake (ABS) Electronic Control Unit on 3400, 3800, RE, FE, and CE bus models built 2/28/1999 thru 4/5/2004

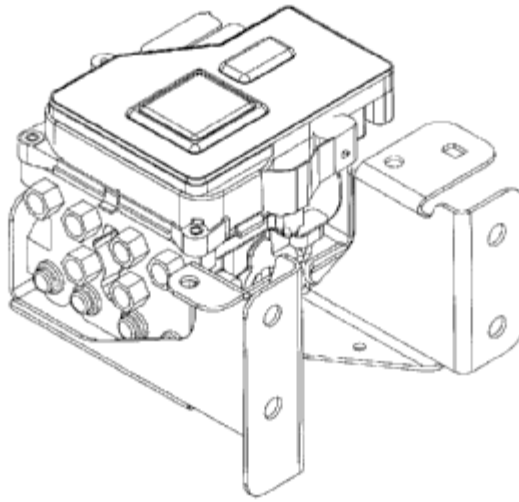
Figure 1

1. Disconnect the negative battery terminal.
2. Locate the EHCU assembly on the driver's side frame rail.

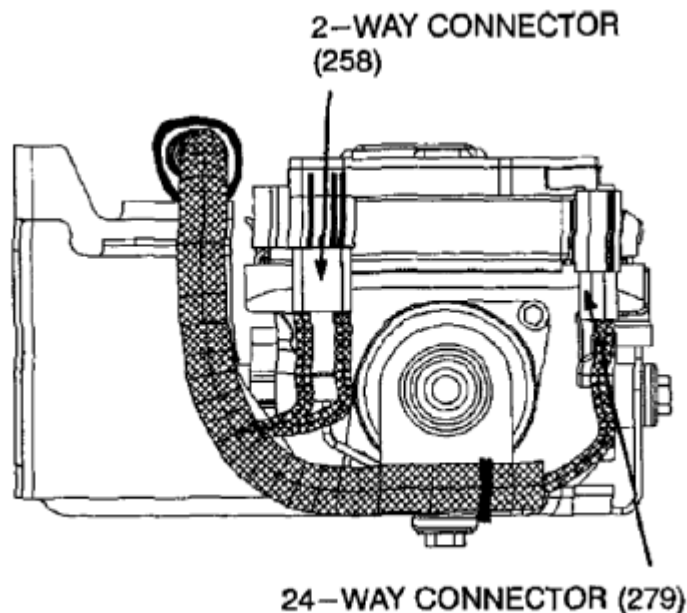
Figure 2 -- View from Rear of Vehicle

3. Remove dirt from the EHCU assembly with a dry soft brush or cloth. Blow loose particles and dust away with low-pressure shop air. **Do not use water or chemical cleaners.**
4. Disconnect the 2-way and 24-way connectors from the ECU.

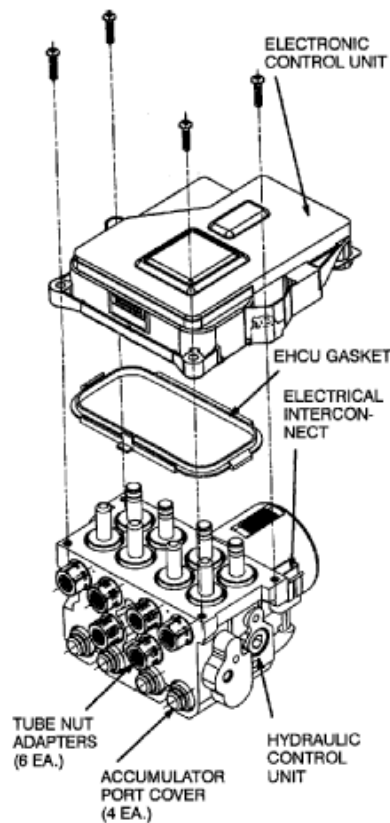
Figure 3

5. Disconnect the 2-way connector from the electrical interconnect between the ECU and HCU (it is located on the side of the EHCUC that was next to the frame rail).
6. With a small hammer, lightly tap the four T-25 Torx® bolts which fasten the ECU to the HCU. Remove the bolts cautiously, so as to ensure they are not broken during removal.
 - a. If bolts cannot be removed due to corrosion, or stripped heads, or if they become broken off, replace entire EHCUC assembly. This is the only condition in which EHCUC assembly replacement will be necessary.
 - Refer to Master Service Manual for proper EHCUC removal and re-installation instructions.
