# VEHICLE RECALL

**G-03513**  
**November 2003**

**SUBJECT: SAFETY RECALL (U.S., EXPORT)**  
**Steering Columns of RE (Rear Engine) and FE**  
**(Front Engine) Busses Built Between 10/28/1993**  
**and 5/21/2003**

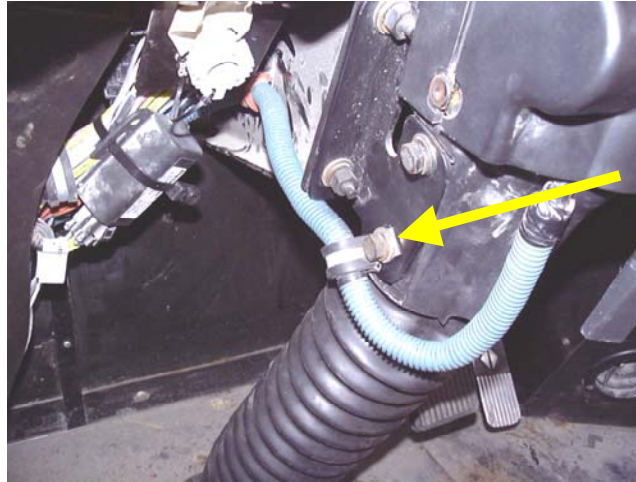
Figure 3

3. Be sure to note which bolt holds the column harness P-Clip in place. (Figure 3).
  - a. *This bolt may be longer than the other steering column mounting bolts. If it is installed in any other hole, it may restrict the steering column's ability to turn freely.*

***TO AVOID STEERING COLUMN DAMAGE AND RESTRICTION OF STEERING SHAFT MOVEMENT, REPLACE HARNESS P-CLIP AND BOLT BACK INTO SAME HOLE.***

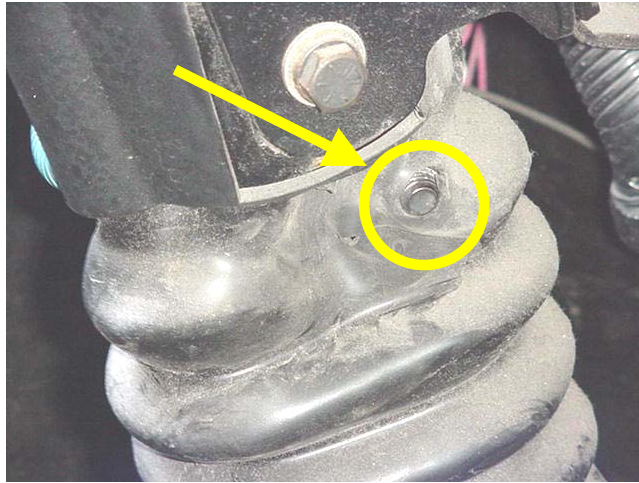
**Figure 9**

10. Inspect steering boot for holes.
  - a. See Figure 9 and 10 for representations and possible locations of a hole.

11. *If a hole is found, continue on to step 12. If no hole is found, skip to step 14.*
12. Remove steering boot from floor.

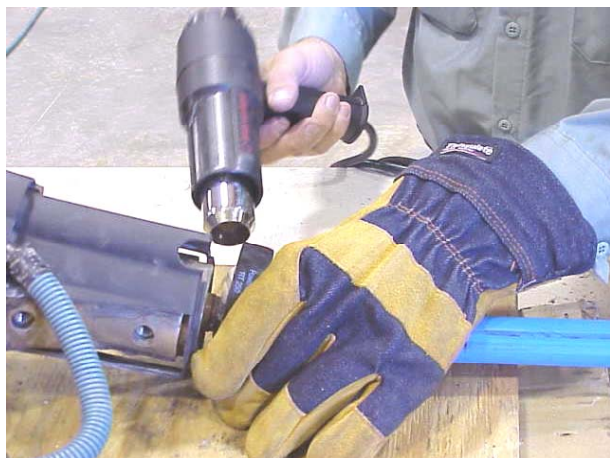
**Figure 12**

A steering shaft yoke pinch bolt, located below the steering column, can catch on the rubber steering boot. If this pinch bolt catches on the steering boot, a sudden resistance in steering movement could occur which may cause a **vehicle crash without warning, possibly** resulting in **property damage, personal injury, or death.**

17. Using a heat gun, apply heat to band clamp until it contracts into place. See Figure 12, 13 & 14.
