Authorized Field Change

AFC G-08905

Subject File: Bus Body

Subject: Instrument Cluster Connector Interference with the Defroster Duct on CE and BE Bus Models with MaxxForce 7 or MaxxForce DT Engines

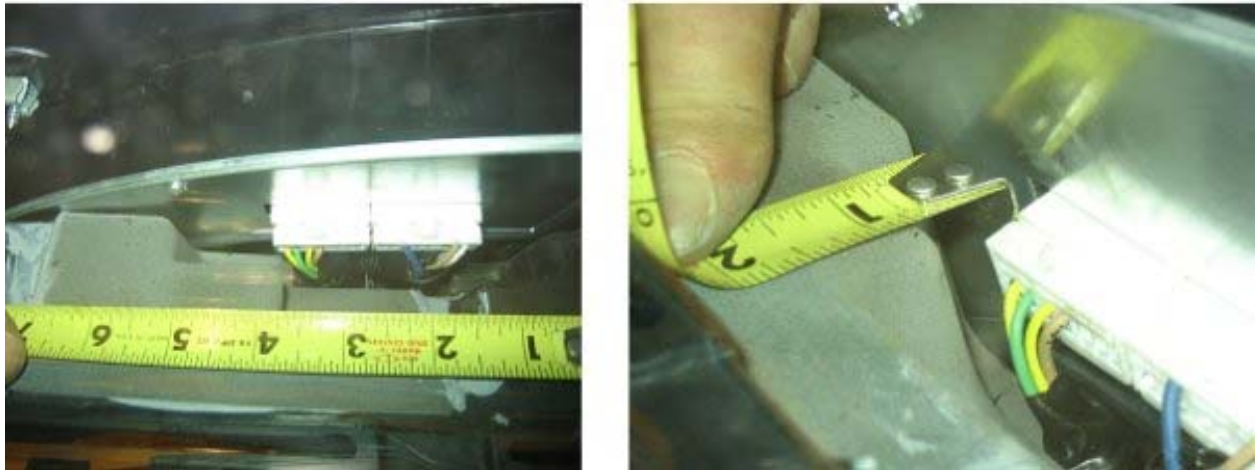
Figure 16

15. Though you will not be able to see the clearance created by the installation of the kit, this is what it looks like with the driver side dash cover off. DO NOT TAKE THE DRIVER SIDE DASH COVER OFF.
