Authorized Field Change

AFC G-05912 Revised

Subject: Certain 5000i and 7000 HPV Models Built Between April 19, 2005 and May 16, 2005 with HMX Rear Suspension Codes 14ULX, 14ULY, May Need the Suspension Equalizing Beams Replaced

SUBJECT: 54" Equalizing Beam Assembly

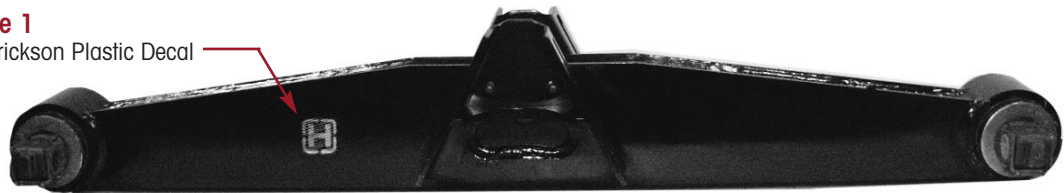
Figure 1

1. Based upon applicable OEM build records, verify whether the equalizing beams were manufactured in the above referenced time period.
2. As of 04/29/05, Hendrickson started installing a plastic Hendrickson decal (see Figure 1) on equalizing beams in our inventory that were determined not to contain any of the non-conforming steel. For those equalizing beams that were shipped between the dates specified above and are equipped with a plastic Hendrickson decal **on the equalizing beam** (see Figure 1), no further action is necessary.

Hendrickson Plastic Decal

3. For those equalizing beams shipped between the dates specified above and are not equipped with a plastic Hendrickson decal, component replacement is required. See Equalizing Beam Replacement in this publication.

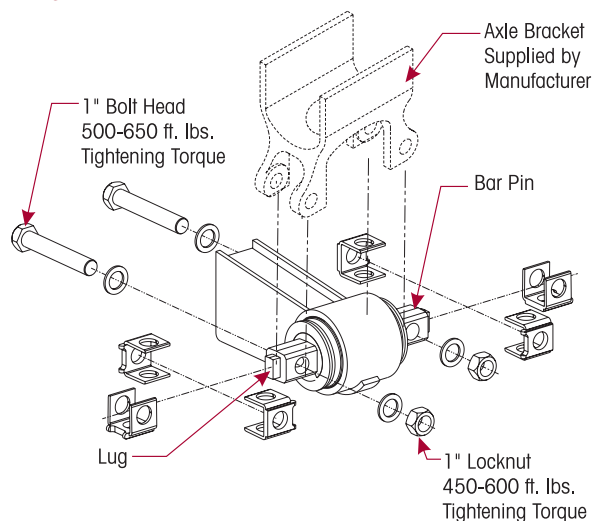
Figure 2

1. Chock the front wheels of the vehicle to help prevent movement during the removal and installation procedures.
2. **Prior to disassembly** of the equalizing beam bar pin fasteners, note the orientation of the bar pin alignment shims. See Figure 2. It is required that the bar pin alignment shims are installed in the same orientation and location as removed to preserve the existing alignment.

14. Partially install the inboard alignment shims and verify that the shims are in the same orientation as prior to disassembly. See Figure 2.
15. To complete installation of the alignment shims, remove the temporary $\frac{3}{4}$ " bolts from the inboard bar pin holes and complete installation of the inboard alignment shims.

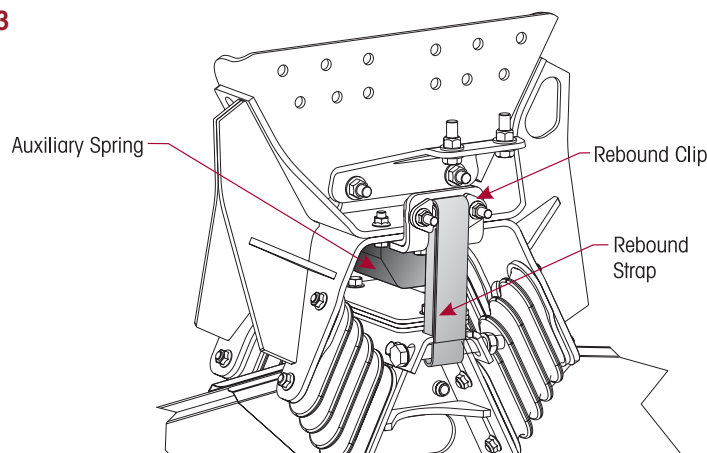
Figure 3

3. From the inboard side of the equalizing beam, remove the two ½" flange head bolts and flange head locknuts from the upper rebound clip and the saddle assembly, see Figure 3.

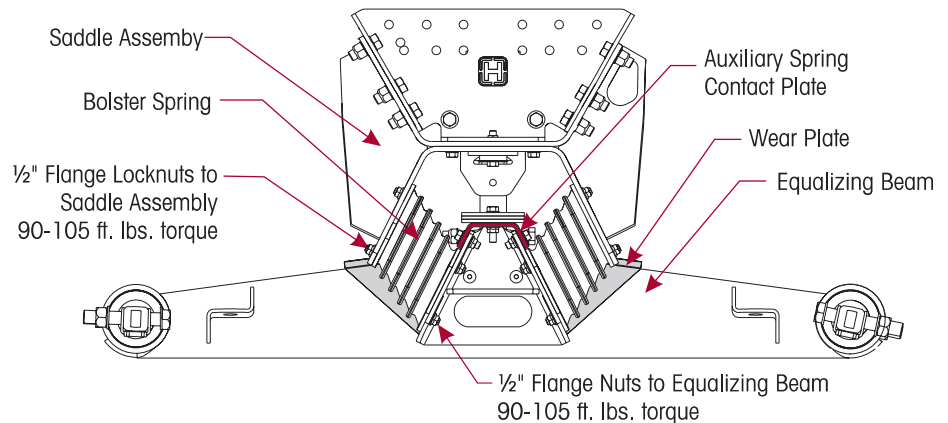
Figure 4

4. Remove the eight ½" flange head locknuts connecting the bolster springs to the equalizing beam assembly. See Figure 4.
5. Loosen the eight ½" flange head locknuts connecting the bolster springs to the saddle assembly. See Figure 4.

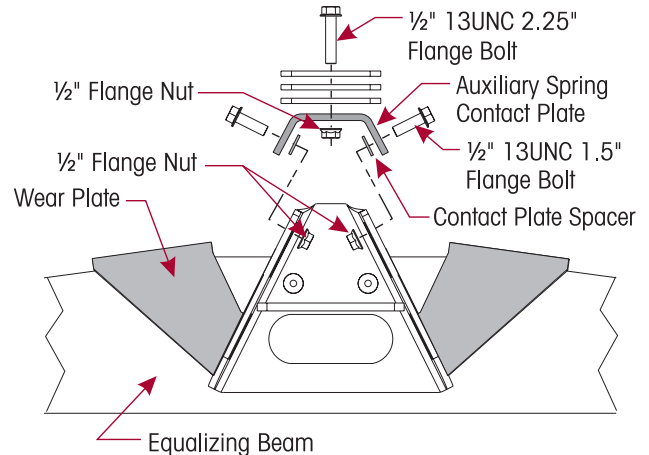
Figure 5

6. Remove the four 1/2" flange head bolts, flange head locknuts and contact plate spacers from the auxiliary spring contact plate and the equalizing beam, see Figure 5. Remove the auxiliary spring contact plate, see Figure 5.

24. Mount the auxiliary spring contact plate to the equalizing beam by installing the four $\frac{1}{2}$ " flange head bolts through the auxiliary spring contact plate, contact plate spacers and equalizing beam assembly, see Figure 5. Install flange head locknuts and tighten to
