# Authorized Field Change

AFC G-05903 Revised

**Subject File:** ENGINE

**Subject:** 5000i and 9000i Models with Cummins ISX Engines Built at the Chatham and Garland Assembly Plants Between November 6, 2002 and April 1, 2004 and 9000i Models Built at the Escobedo Assembly Plant Between November 6, 2002 and October 18, 2004 Require Replacing the Fan Hub Mounting Fasteners and Tighten to New Specification

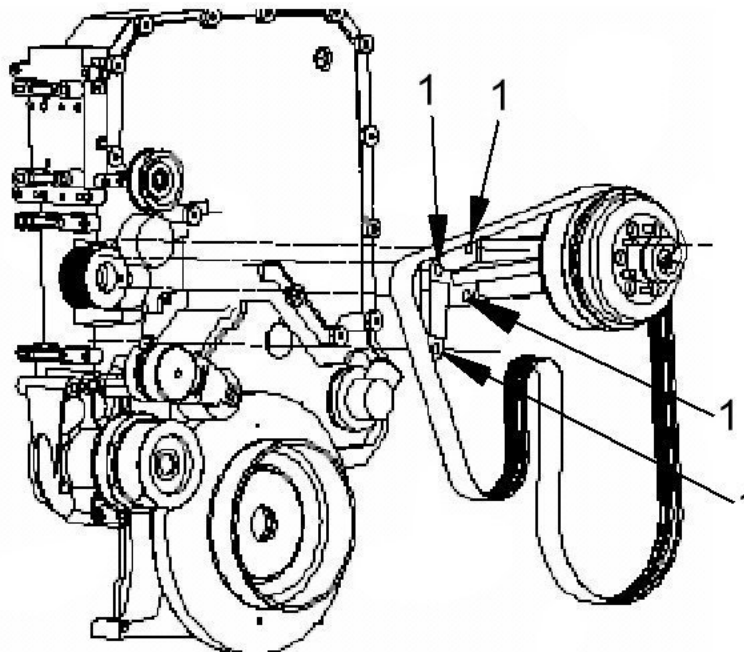
**Figure 1 Replace Fan Hub Mounting Bolts**

The vendor recommended torque specification is not adequate for the fan hub mounting bolts. It is possible the fan hub mounting bolts may loosen resulting in fan and radiator damage.

1. Fan Hub Mounting Bolts

1. Remove the tension from the fan belt.
2. Remove **one** hub mounting bolt and replace with the equivalent bolt from the kit. Turn the bolt until the bolt flange is in contact with the hub flange.
3. Repeat the procedure for the three remaining bolts.
4. Tighten the fan hub mounting bolts to 80 to 100 Lbf-ft (108 to 136 Nm).
5. Re-install the fan belt.
