IC Corporation

SAFETY RECALL 05524

February 2006

VIN # (or List of VINs repaired)
Recall Campaign #05524
SUBJECT (Bus Control Arm Bracket)
Facilities Repair Labor Rate
Labor Operation Number
Your Tax ID Number

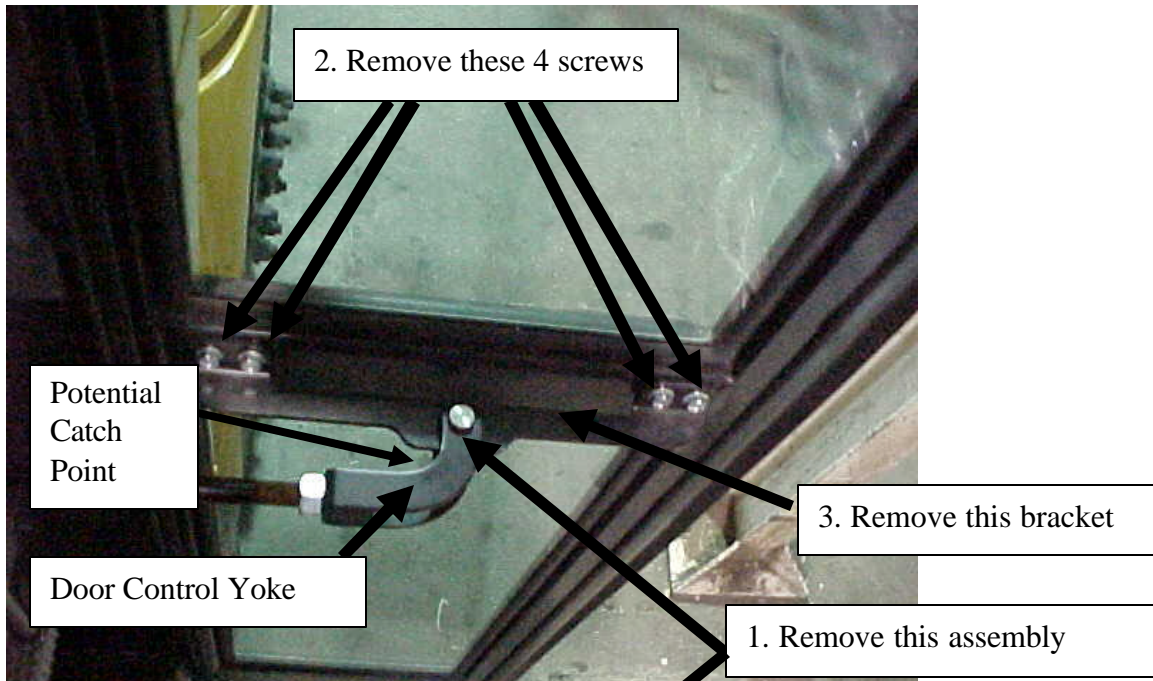
Figure 1. Old Bracket and Assembly

There is a bracket mounted on the door that the door control yoke is attached to (See Figure 1, Potential Catch Point.) Certain small objects, including, but not limited to, coat tie strings with draw string clips or other objects attached thereto, could get caught in this catch point. Should this happen, and the driver does not properly observe the person exiting the bus, the person may exit the bus with the string caught between the bracket and the yoke. The door may be closed and the bus moved, causing possible injury or death to the passenger exiting the bus.

Remove Old Bracket: Refer to Figures 1 & 2.

1. Remove the door control yoke from the old bracket.
 - a. Remove the snap retainer at the bottom of the assembly.
 - b. Pull the clevis pin.
 - c. Be sure to note the order in which the parts are removed so they can be replaced or reinstalled in reverse order.
2. Remove the 4 screws that hold the bracket to the door. These screws are screwed into tapped holes. Be careful not to damage the threads of the tapped hole.
3. Once the 4 screws are removed, the old bracket can be removed.
