RECALL NOTICE

IC CORPORATION RECALL # 04303
NHTSA RECALL # 04V- 359

August 2004

Vandal Lock Warning

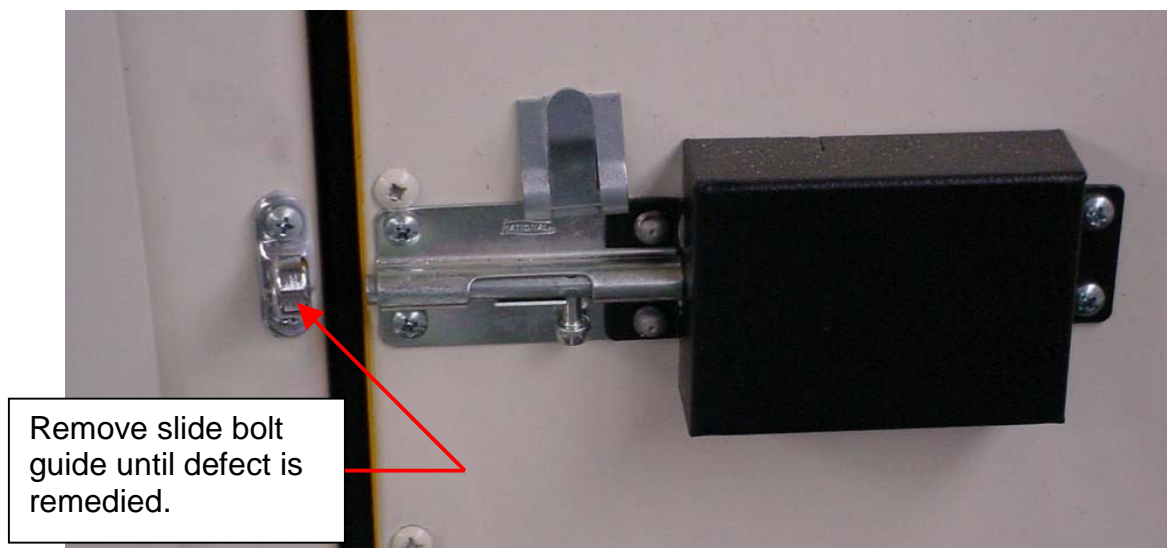
If the Vandal Lock system (interior emergency door locking system) is applied while the engine is running, there is no warning to the driver. In the event of an emergency, disengaging the Vandal Lock will increase the time to open the emergency exit door and could prevent rapid egress from the bus. Preventing rapid egress from the bus could possibly result in personal injury or death.

Vandal Lock Installed At Emergency Door

Removal of the Vandal Lock slide bolt guide from the door until the defect is remedied will prevent the door from being locked. See picture below. The removal of the guide is accomplished by removing the two screws attaching the guide to the door. Retain the screws and guide for reinstallation after the defect has been remedied.
