# Authorized Field Change

**AFC G-01901**

**Subject:** Frame Cracking at the Steer Axle Shock Absorber Bracket Mounting Bolts in the 3000RE Bus Model Built Before January 16, 2001

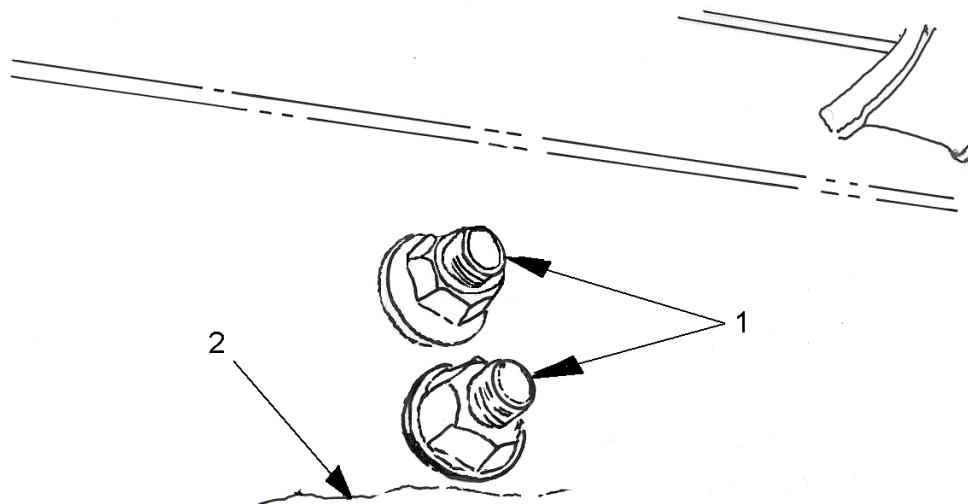
Due to the dynamics of shock absorber forces, the stress levels in the frame web at the steer axle shock absorber bracket mounting bolt locations may exceed the frame material yield strength and may result in cracks as shown in Figure 1. Effective January 16, 2001, a frame reinforcement was implemented in production to address this issue.

**Figure 1 Front Shock Absorber Frame Rail Mounting Area Illustrating a Crack as Viewed from Inside the Frame Rail**

1. Shock Absorber Bracket Mounting Bolts
2. Area of Possible Cracking

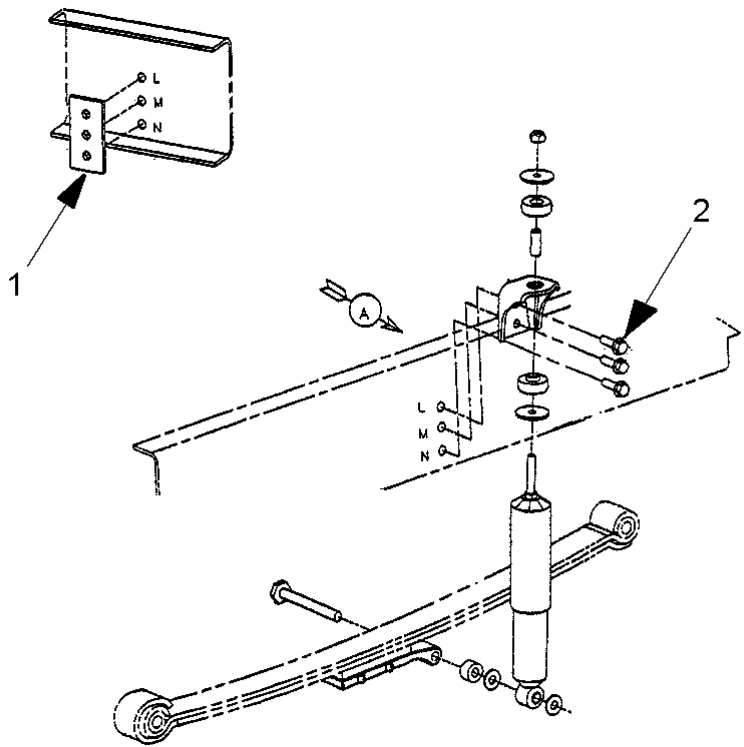
**Figure 2** Installing the Shock Mounting Reinforcement to Repair or Prevent Frame Rail Cracks

1. Shock Mounting Reinforcement Part Number 3563097C1
2. Fastener Part Numbers 414078C1 Bolt and 414089C1 Nut

2. Clean and inspect the area around the shock absorber mounting holes for evidence of cracking. If cracks are not found, proceed to Step 3. If cracks are found, repair by welding before proceeding to Step 3. Refer to Service Section S01001Y, Frame, in Group 01 of the Master Service Manual for welding information that applies to 50,000 PSI yield strength frame material.
3. Install two new bolts, part number 414078C1, into the shock absorber mounting bracket, pivot the shock absorber into position inserting the bolts into the frame mounting holes.
4. Position the shock mounting reinforcement, part number 3563097C1, top two holes onto the two bolts.
5. Install two nuts, part number 414089C1 and tighten to 200 to 240 Lbf-Ft (271 to 325 Nm).

6. Drilling from inside the frame rail, use the bottom hole in the shock mounting reinforcement as a template and drill a 5/8 inch diameter thru hole in the frame.
7. Left frame rail (driver's side): Install bolt part number 414078C1 through the frame, shock mounting reinforcement and hose clip, install nut part number 414089C1 and tighten to 200 to 240 Lbf-Ft (271 to 325 Nm).

Right frame rail: Install bolt part number 414078C1 through the frame, shock mounting reinforcement, install nut part number 414089C1 and tighten to 200 to 240 Lbf-Ft (271 to 325 Nm).
