INTERNATIONAL TRUCK AND ENGINE CORPORATION
4201 WINFIELD ROAD, WARRENVILLE, IL 60555

SAFETY RECALL INTERIM ACTION 04521

February 2005

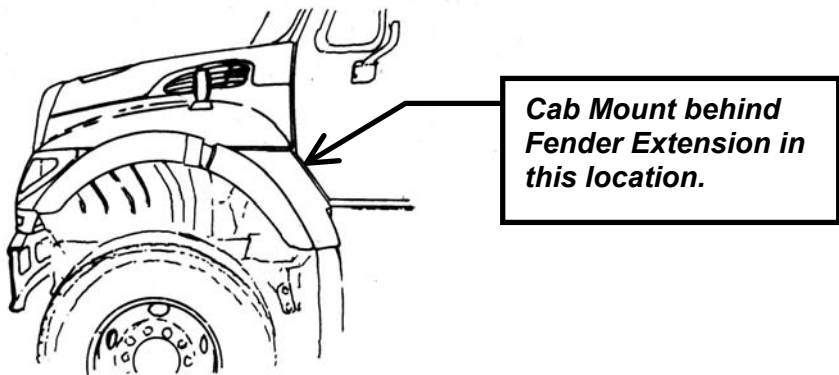
**Figure 1 – Front Cab Mount Bolt Location
(7000 Series shown, 8000 Series location is same)**

During the assembly of your vehicle, there were sixteen front cab mounting fasteners that may not be tightened sufficiently. This hardware connects the cab to a cast bracket that is connected to the rubber portion of the cab mount. Normal use of the vehicle may result in these under-tightened fasteners loosening and falling out.

- The front cab mount bolts are located under the front of the cab, behind the fender extension. Eight (8) bolts are used on each side of the vehicle.

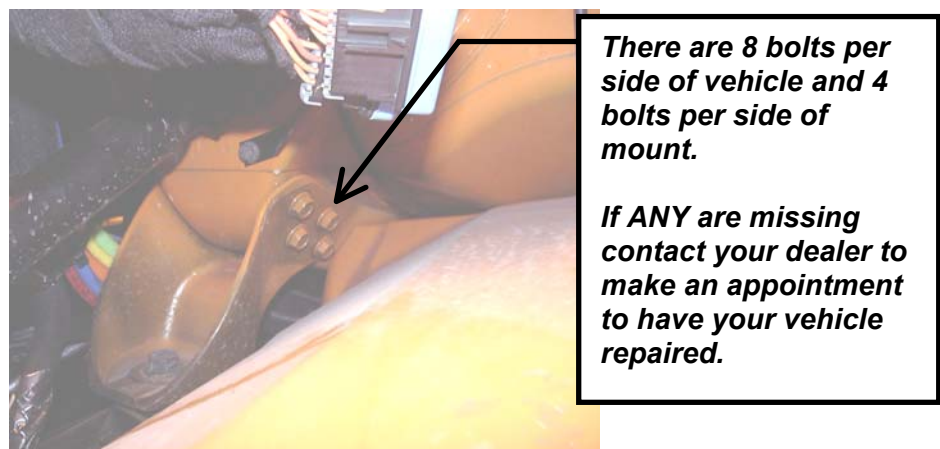
**Figure 2 – Front Cab Mount Bolts
(Mid-Mount shown, High Mount uses different bracket, but same bolt configuration.)**

- Open and secure hood. Inspect all sixteen (16) bolts.

- Removal of the fender extensions is required for bolt tightening. Mid-High mounted cabs (4400, 7300, 7400, 7500, 8500) will have three (3) fasteners attaching each fender extension while High mounted cabs (7600, 7700, 8600) will have four (4) fasteners for each fender extension.
- Ensure bolts are properly tightened to **115-120 LbF-Ft (156-163 Nm)**.
