Authorized Field Change

AFC 01912

Subject: Frame Crossmember Bracket (Gusset) Replacement for 5000i Models Built Between February 28, 2000 to May 9, 2001 with 5 Piece Intermediate Crossmember

Truck Model: 5000i

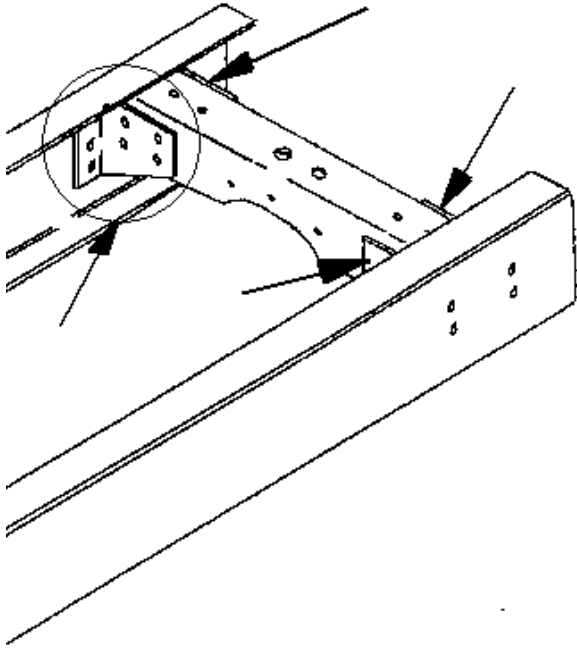
5000i Models built between February 28, 2000 to May 9, 2001 may have frame crossmember brackets, used with 5 piece intermediate and/or front rear suspension crossmembers, made from steel that does not meet specification and press bend marks that could lead to premature failure.

Figure 1 Frame Crossmember Bracket Locations Indicated By Arrows

1. Remove four frame crossmember bracket mounting bolts and nuts. Retain for reassembly.
2. Remove two frame crossmember bracket Huckbolts using an approved method.
3. Install a new frame crossmember bracket to the crossmember with the fasteners removed in Step 1. Tighten to 75 to 85 Lbf-ft (102 to 115 Nm).
4. Mount the bracket to the frame with two 5/8 inch bolts and nuts provided in the kit. Tighten to 160 to 175 Lbf-ft (217 to 237 Nm).
5. Repeat Steps 1 to 4 for the remaining three bracket locations on the crossmember.
6. Continue to the next 5 piece intermediate and/or front rear suspension crossmember until all 5 piece intermediate and/or front rear suspension crossmembers have been repaired.
