# Technical Service Information

**TSI-04-12-05**

**Subject:** Clutch Damper Interference with Flywheel Bolts on Caterpillar 3406E, C-15, C-16 Engines

TMIB-0140

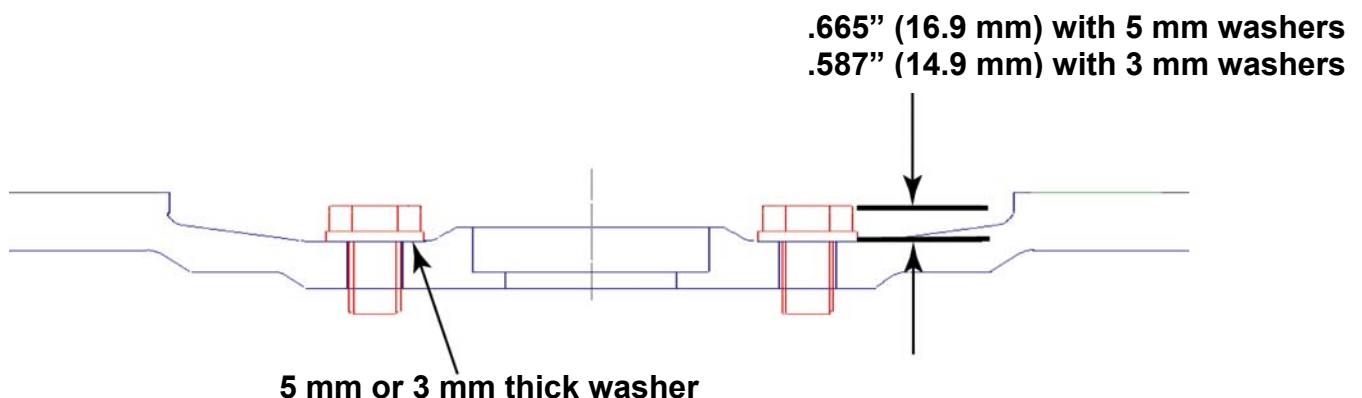
Caterpillar 3406E, C-15, C-16 built or serviced with the VCTplus clutch damper, introduced in April 2003, have the possibility of the clutch damper interfering with the flywheel mounting bolts.

Any repair that has required the transmission to be removed from the truck and the engine serial number is 5EK1 and up, 6TS1 and up, 1LW1 and up, 2WS1 and up, 6NZ1- 92122, 7CZ1 – 04382, MBN1 – 21447, BXS1 – 00984, 5DS1 and up, or 1MM1 and up, you must verify the 5mm washer has been replaced with the 3mm washer, Caterpillar part number 8D-5054. Failure to replace the washers could result in damper rivet interference. Torque the bolts to 270 Nm +/- 40Nm (200lb. ft. +/- 30 lb. ft.) and apply paint to bolt heads for completion identification.
