Authorized Field Change

AFC 06902

Subject: Valve Cover and Breather Upgrade for Certain International® 3200 and 4200 Models Built Between November 1, 2001 and December 31, 2002 with International® VT 365 Engines

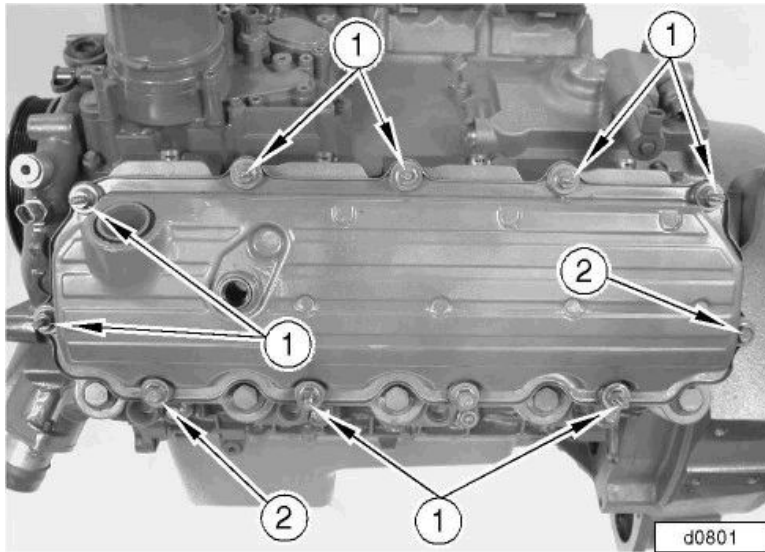
Figure 1 Remove Studs and Bolts

- 1. Stud Locations
- 2. Bolt Locations

2. Disconnect the battery ground cable.
3. Remove the air cleaner housing with tube attached, disconnect the intake ambient temperature sensor (IAT), and ventilation tube from the valve cover.
4. Remove the electronic control module (ECM) with IDM and wiring.
5. Disconnect and remove the ECM wiring.
6. Remove the oil fill tube from the valve cover. Disconnect and remove the window washer reservoir from the mounting bracket.
7. Remove the exhaust back pressure sensor EBPS tube at the sensor.
8. Remove the ECM mounting bracket, disconnect the EBPS wiring, and remove the tube.
9. Remove the dip stick tube.
10. Disconnect the crankcase ventilation breather assembly and remove the remaining air duct from the turbocharger.
11. Remove the studs, bolts (Figure 1) and left valve cover.

- 12. Inspect the valve cover gasket and replace only if necessary and install the new valve cover onto the rocker arm carrier.
- 13. Install the valve cover mounting bolts and studs in the correct locations as shown in Figure 1. Leave the bolts finger tight until all bolts and studs are installed then tighten to 60 to 84 Lbf-in (7 to 9 Nm).
- 14. Install the new o-ring onto the breather pipe and install the new breather hose assembly and hose clamp.
- 15. Install the new air inlet duct to turbocharger.
- 16. Continue following Steps 1 through Step 9 in reverse order.
