VEHICLE RECALL

IC CORPORATION RECALL # 02302
NHTSA RECALL # 02V-200

SUBJECT: VEHICLE RECALL
RE STEPWELL JOINT

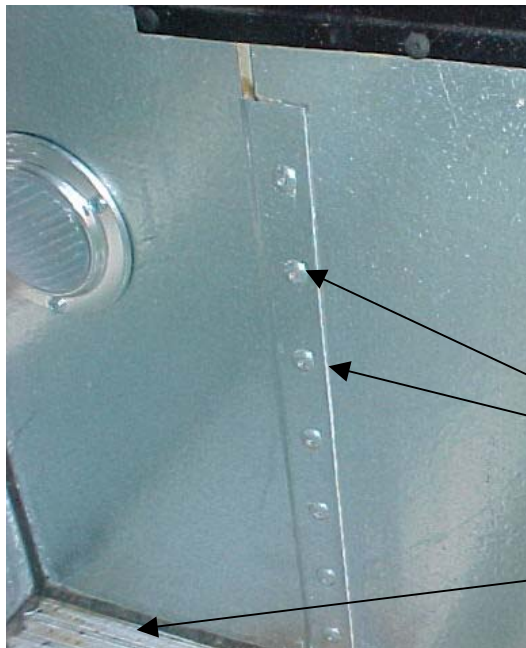
Picture # 1 (NON-COMPLIANT)

On some of the subject RE buses, if the vertical joints on the forward and rear side of the stepwell are assembled with rivets only, at a spacing of about two inches, the stepwell is incorrectly assembled and will not meet joint strength requirements per the above regulation. See pictures below that show the location and types of the joints.

Picture of riveted vertical joint on the forward side of the entrance door stepwell that reaches from the second step to the floor trim. This same joint is duplicated on the rear side of the stepwell. This picture shows the vertical joint assembled with rivets at a spacing of about two inches and does not meet the requirements of the regulation.

The customer was told, if the joint is assembled with rivets spaced at approximately two inch increments (no additional screws or rivets) the joint must be repaired (reference Picture # 1). Follow the repair procedures stated below.

This repair procedure involves adding approximately 26 screws, (13 per side) to the vertical joints. No special tools are required. Pilot holes must be drilled prior to installing the screws using a 3/16-inch (#10) bit. Screws are to be located as follows. Insert one screw approximately 1 inch above the top rivet but no closer than about ½ inch from the top edge of the metal piece on the forward joint and not to interfere with the floor trim piece on the rear side of the stepwell. Then insert two screws evenly spaced between the existing rivets.

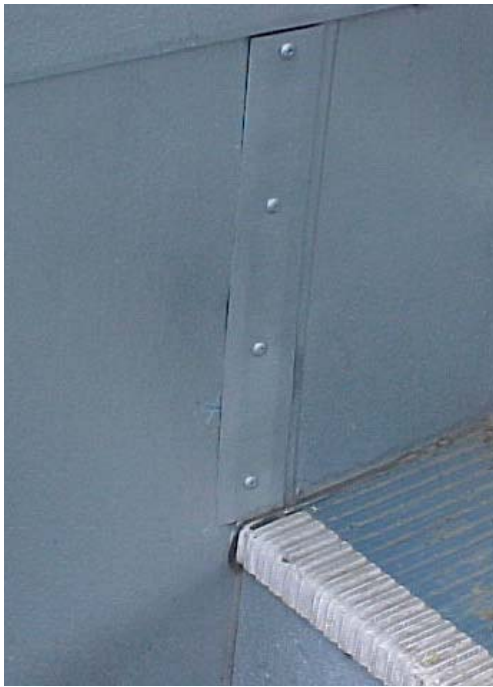
Picture # 2 (COMPLIANT)

Picture of welded vertical joint on the rear side of the entrance door stepwell that reaches from the second step to the floor trim. This same joint is duplicated on the forward side of the stepwell. This picture shows welded joint with a trim part covering the seam. This joint is compliant and is not involved in the recall.

If the joint is not assembled with rivets and has a trim panel with a few screws (reference Picture # 2), it does not require repair. Please complete and return the enclosed “**AUTHORIZATION FOR RECALL SERVICE**” card with box # 1 checked (Inspected - No corrections necessary).

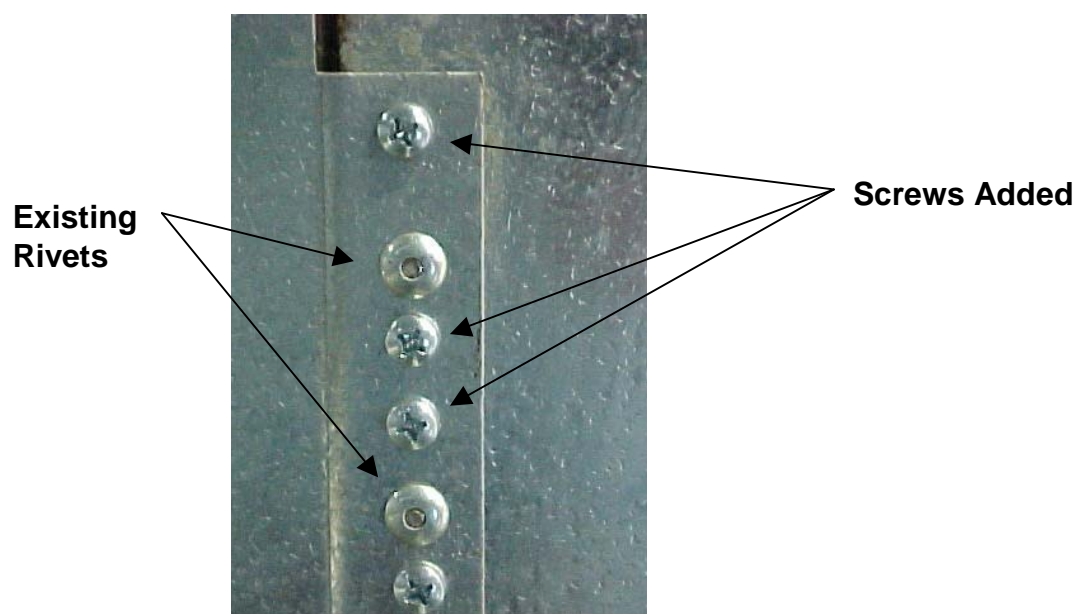
Example Showing Repair to the Forward Joint By Adding Screws
