VEHICLE RECALL

G-04503
July 2004

SUBJECT: SAFETY RECALL (U.S., EXPORT)
BUNK CONTROL PANEL of certain 9100, 9200, 9300, 9400, and 9900 models built 4/1/1994 thru 6/16/2002

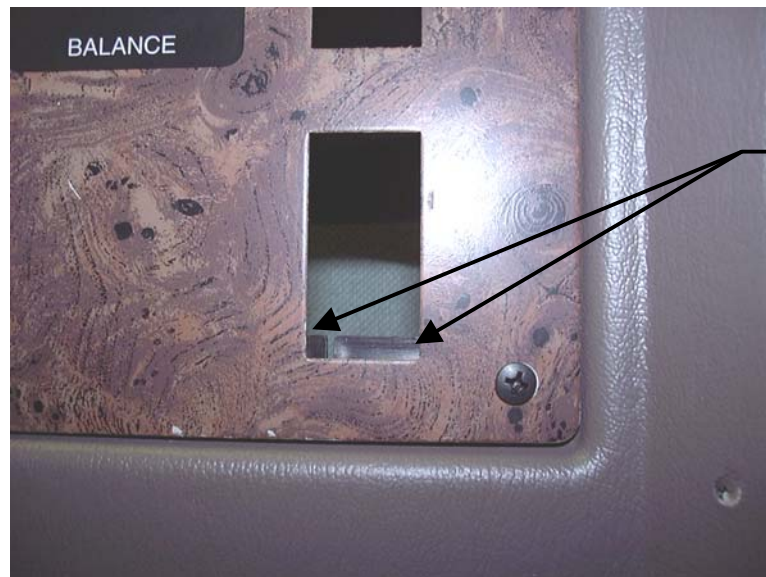
Figure 1

- Water shield flange may interfere with lower switch body

1. Inspect the bunk control panel to determine if a vehicle contains all three switches, dome light, TV/VCR, and refrigerator.
 - a. If a vehicle does contain all three (3) switches, some small re-work is required. If a vehicle DOES NOT contain ALL three switches, skip to step 3.

2. Cut a small notch in the flange to clear the bottom of the switch.
