# VEHICLE RECALL

**G-03510-R1**  
**March 2004**

**SUBJECT: SAFETY RECALL (U.S., EXPORT)**

**Unitized Wheel Hub on Certain 4000, 8000, and 9000 Series  
Models Built 1/9/1998 through 3/1/2002 and Certain Service  
Replacement Unitized Wheel Hubs Installed 5/21/1999 thru  
5/2/2000**

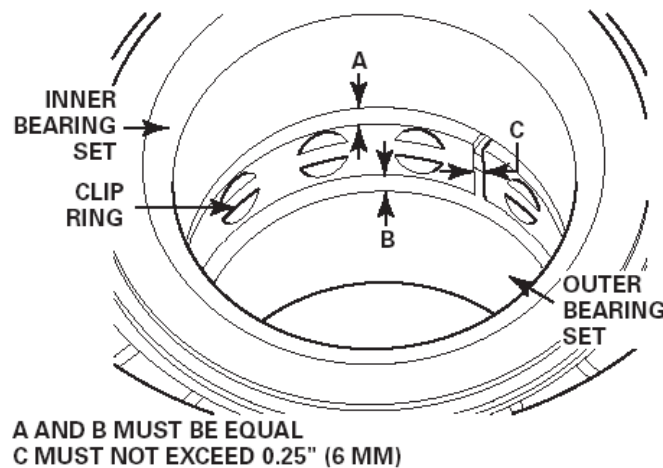
**Figure 2**

1. Remove the replacement hub from the box and place it on a clean surface.
2. Examine the interior of the hub to verify the following:
  - A. The inner clip ring has not become dislodged in shipment and is in correct alignment with the inner and outer bearings. The gap between the inner and outer bearing sets and the clip ring must be equal (Dimensions A & B). See **Figure 2**.
  - B. The gap between the ends of the clip ring and inner/outer bearing set must be equal and not exceed 0.25-inch (6 mm). If necessary, adjust by hand (Dimensions A, B & C). See **Figure 2**.
  - C. The bearing face must be clean with no seal coating, dirt or dust.

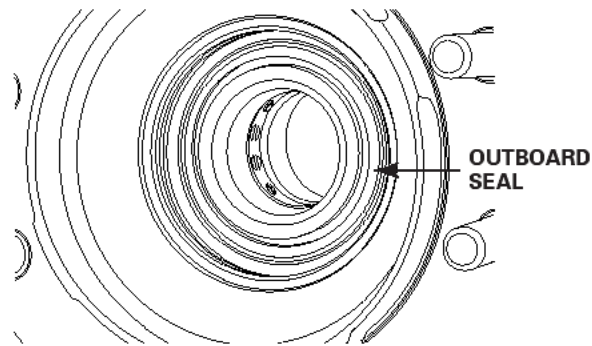
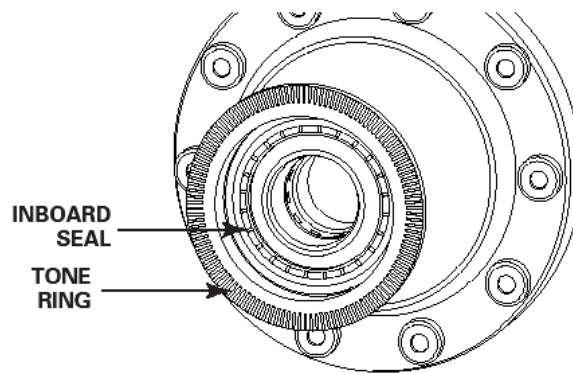
3. Examine the exterior of the hub to verify the following:
  - A. There is no visible damage to the inboard or outboard seals and the bearings have not become unseated. Refer to Figure 3 and Figure 4.
