# Authorized Field Change

AFC G-06904

**Subject:** Engine Air Management System Upgrade for Certain International® 3200 and 4200 Models Built Between November 1, 2001 and December 31, 2002 with International® VT 365 Engines

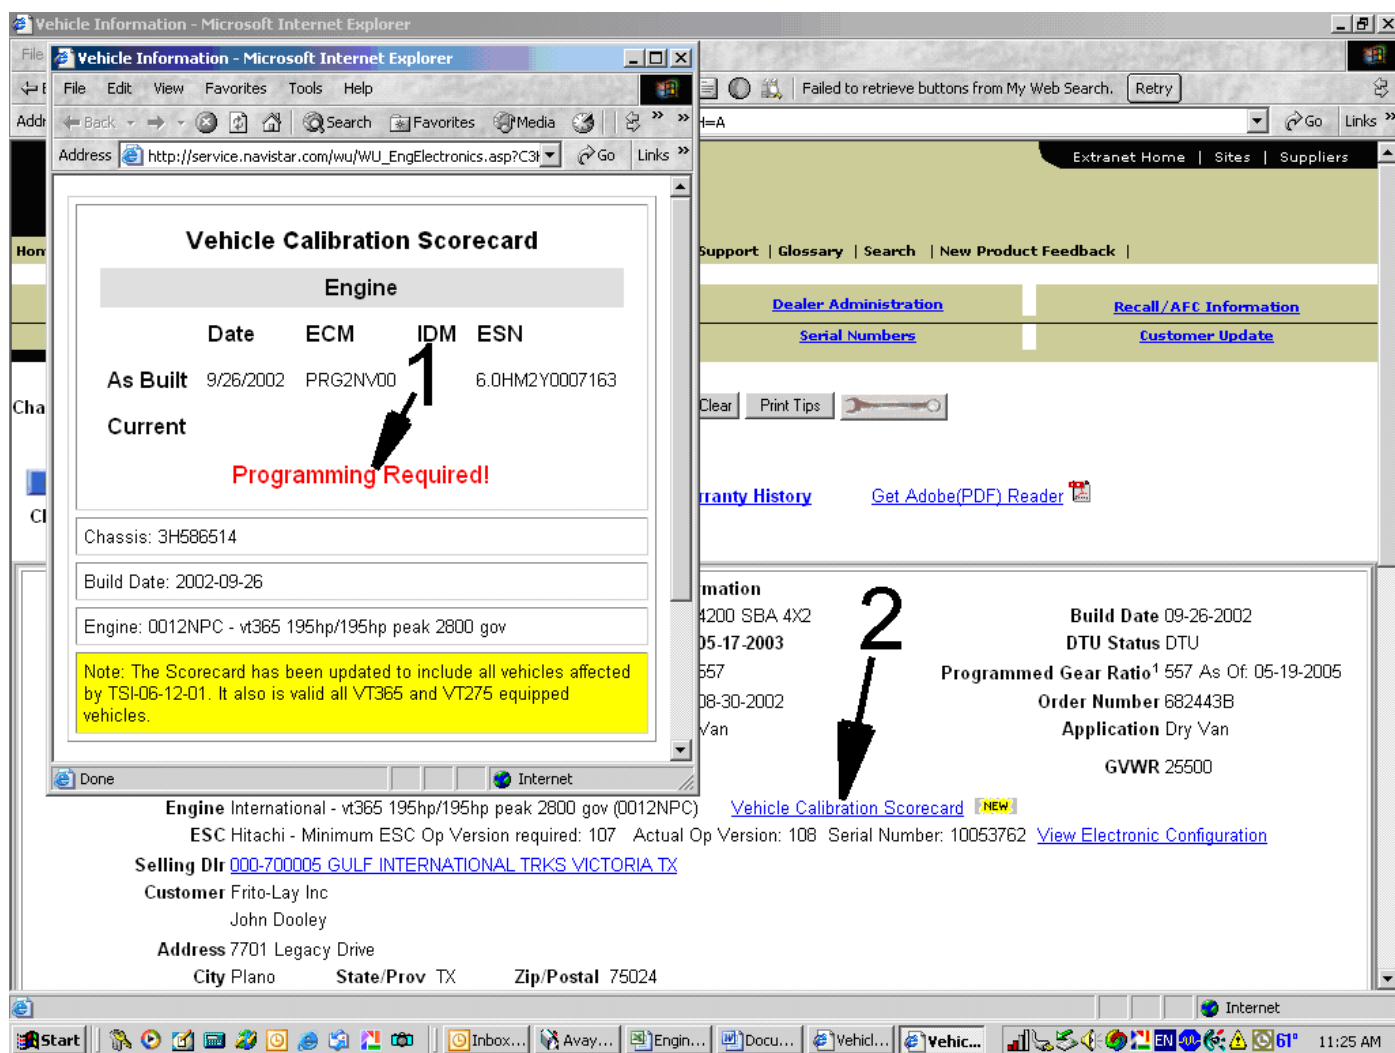
**Figure 2 Old ISIS Screen**

1. Programming Required
2. Vehicle Calibration Scorecard

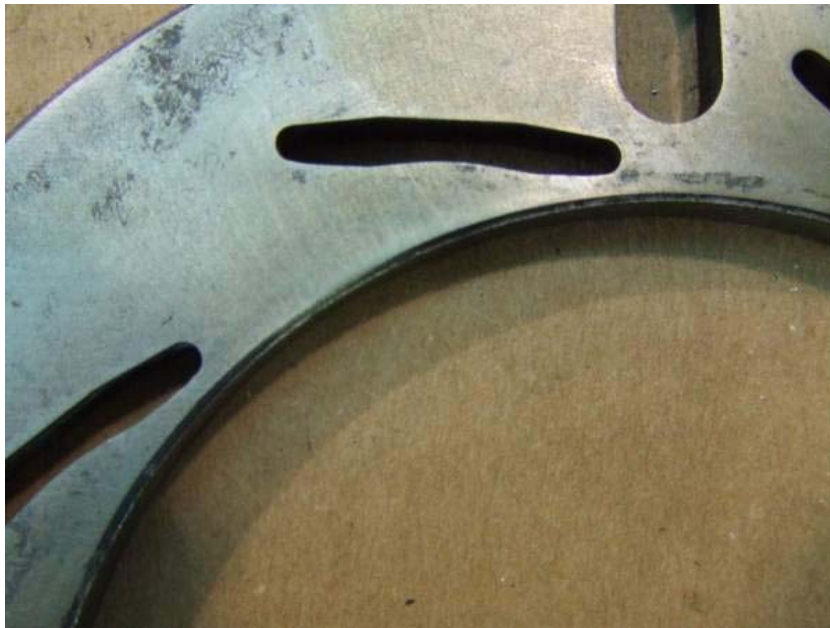
10. Inspect the unison ring for cracks or excessive wear. If either is found, the turbocharger cannot be reconditioned (Figure 8 and Figure 9).

**Figure 8 Unison Ring can be Reconditioned**

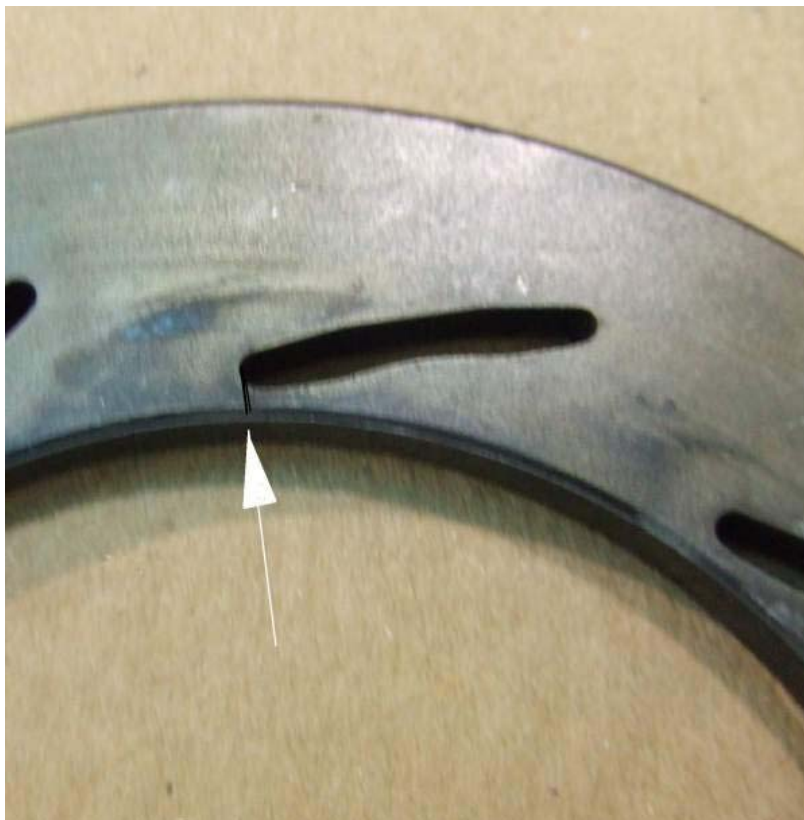
**Figure 9 Unison Ring Cannot be Reconditioned (Crack at Arrow)**

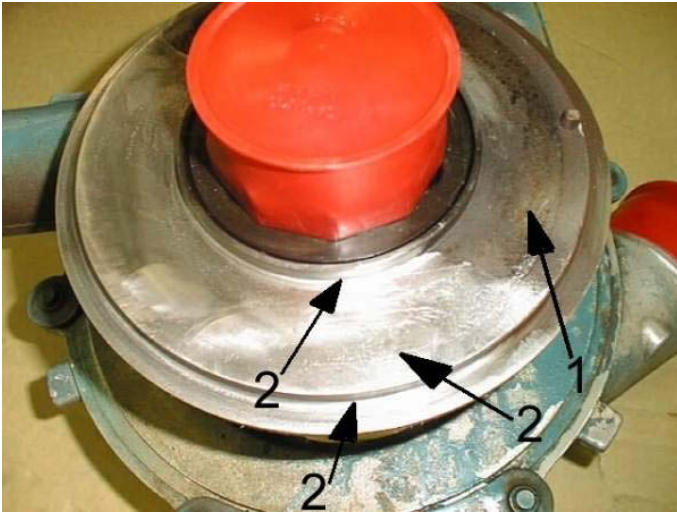
**Figure 10**

1. Un-Cleaned
2. Cleaned

11. Clean the center section (Figure 10):

- Using 2 inch 3M® cleaning pad, remove corrosion from surfaces that contain moving parts and mating housing joints.
- Using the least aggressive cleaning disc, clean surfaces until all corrosion and carbon has been removed. Take care to prevent damage or gouging the machined surfaces of the housings or unison ring cam.

12. Clean the pilot area of the center section that contacts the unison ring. Remove debris from the housing with brake cleaner and compressed air (Figure 10).

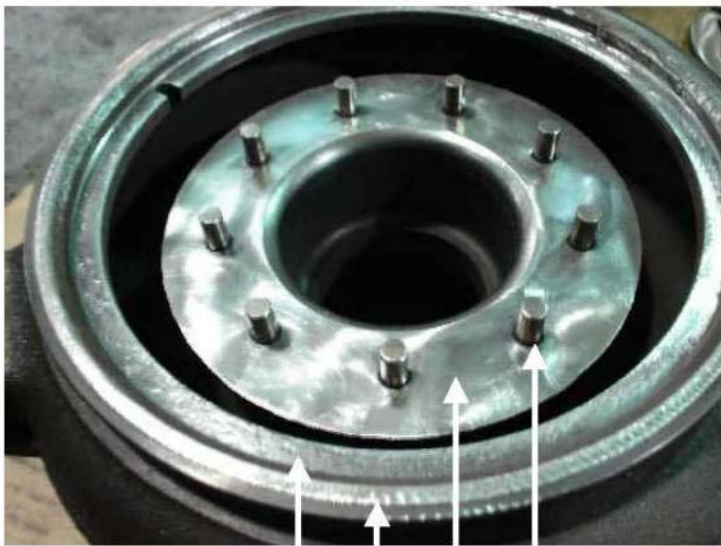
**Figure 15**

Areas to clean

16. Using the modified cleaning disc, remove corrosion from all surfaces that contain moving parts in the turbine housing and mating surfaces of the housing (Figure 15).

- Aggressively clean surfaces until all corrosion and carbon have been removed and bright shining metal surfaces are exposed.
- Take care to prevent damage to the machined surfaces and housing vane posts.
- Remove debris from the housing with brake cleaner and compressed air.
