Authorized Field Change

AFC G-07906

Subject: Install EGR Cooler Deaeration Hose Restrictor

Model: 1300, 3200, 4300, 4400, 8500, CE, FE, RC, and RE Bus

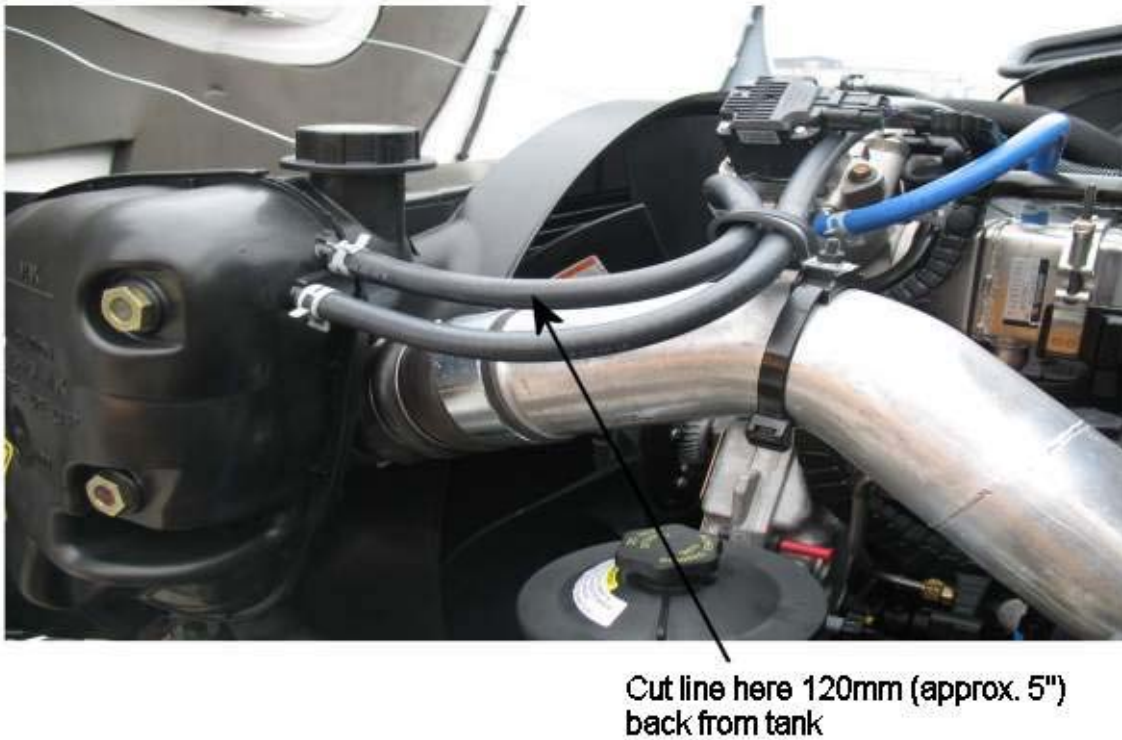
Figure 1 EGR Cooler Deaeration Hose Restrictor

MaxxForce DT engines are experiencing inadvertent low coolant warning light/buzzer activation.

It has been determined by International Truck and Engine Corporation that the above listed models were built with an EGR cooler deaeration hose that the inside diameter is too large and the restrictor fitting needs to be installed.

1. Loosen coolant system pressure cap.
2. Measure back 120 mm (approximately 5") on the top deaeration hose at the surge tank (Figure 1).

3. Cut deaeration hose at the 120 mm (approximately 5") from the surge tank.
4. Install hose clamps from the parts kit on the hose on both sides of the cut.
5. Install restrictor. You will notice that the restrictor has a large hole in one end and a smaller hole in the other end, it makes no difference which way the restrictor is installed.
6. Slide clamps along the hose so they are positioned over the ends of the restrictor.
7. Tighten coolant system pressure cap.
8. Check for leaks and insure that the surge tank is at the full level.
