Technical Service Information

TSI-04-13-01

Subject: Addition of Fault Code 91 and Revised Electrical Pretest for Eaton AutoShift Transmissions

TAIB-0804

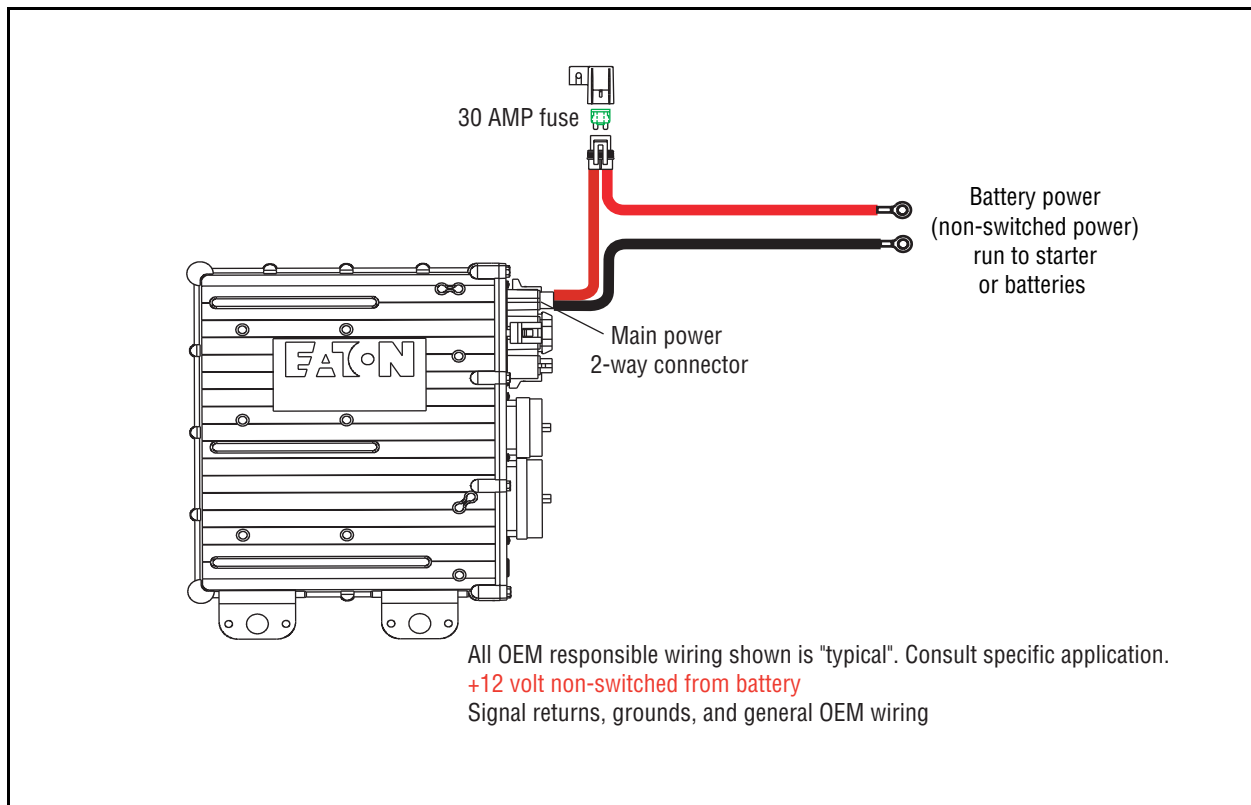
- OEM Wiring Harness between battery or starter and transmission controller.

Step A	Procedure	Condition	Action
	1. Key off.		
	2. Disconnect the main power 2-way connector on the Transmission Controller. Disconnect battery power supply from vehicle. (may be starter post or battery) check with OEM for exact location		
	3. Inspect main power two-way connector terminals, in-line fuse holder, and power supply connections for integrity and corrosion.

Repair power/ground path for the main power supply. Go to **Step V.**

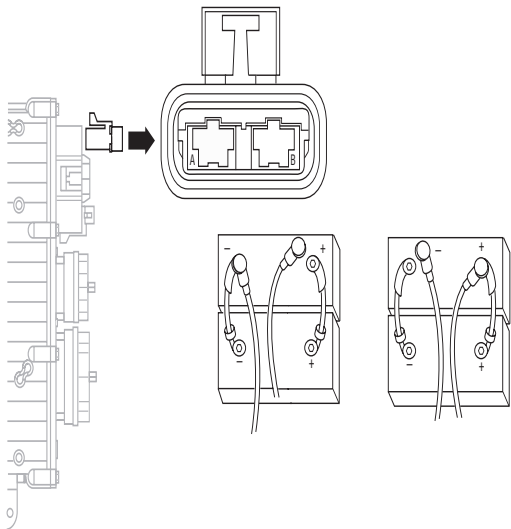
Code 91
(SID 251, FMI 5)

Step V	Procedure	Condition	Action
	1. Key off.		
	2. Clean and reconnect all connectors.		
	3. Key on.		
	4. Clear codes (see page 1-3).		
	5. Use Driving Techniques to attempt to reset the code (see page 1-4).		
	6. Check for codes (see →	If no codes →	Test complete.
	page 1-3).	If code 91 appears →	Return to Step A to find error in testing.
		If code other than 91 appears →	Go to Fault Code Isolation Procedure Index (see page 1-8).
