April 2005

SUBJECT: SAFETY RECALL (U.S., EXPORT)
**TURN SIGNAL SWITCH assemblies on certain 3300,
4200, 4300, 4400, and CE School Bus models built
5/24/2004 thru 8/17/2004**

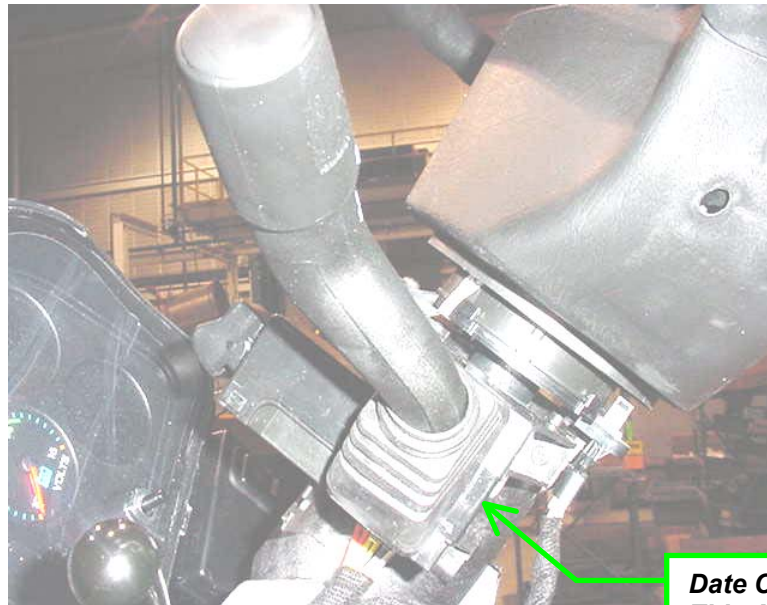
Figure 2

***Date Code in
This Area***

2. Inspect the underside of the turn signal stalk assembly for the build date code.

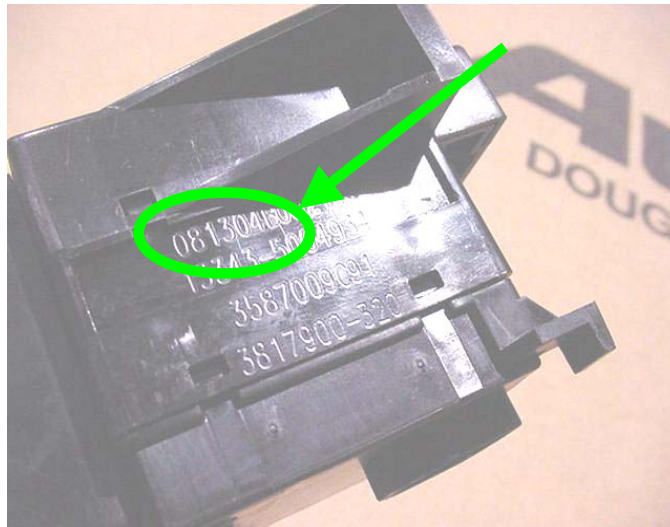
Figure 3

NOTE: The example in Figure 3, 081304, corresponds to a build date of August 13th of 2004.

3. Replacement of the turn signal switch is required if the switch build date codes are between **051504** (May 15, 2004) thru **062804** (June 28, 2004). If the build date is within this range, skip to step 5.
4. If the date code on the switch assembly is **NOT** in the range listed in step 3, **NO FURTHER ACTION IS NECESSARY**, re-install lower column trim panel and fasteners.
