American Transportation Corporation

RECALL NOTICE

AMERICAN TRANSPORTATION RECALL # 01303
NHTSA RECALL # 01V-269

Dear American Transportation Bus Customer:
Issue: Flip Seat Support Binding

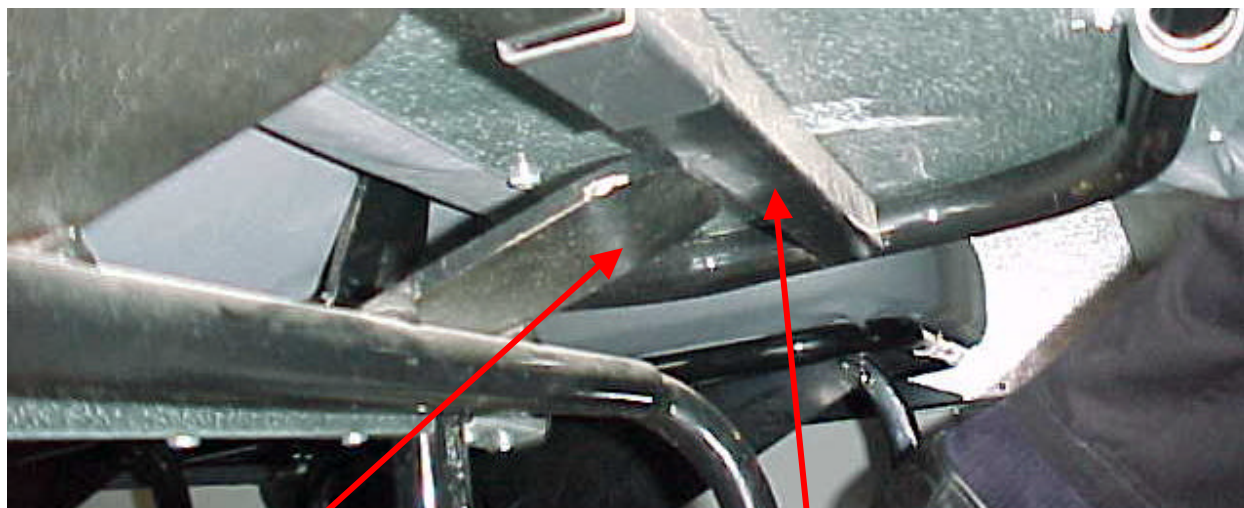
The cushion frame support bar slides off the seat support pad. When this occurs, the tabs can wedge against the support bar, which may retain the seat in the occupied position.

Picture Showing Cushion Frame Support Bar Ready to Slip Off Seat Support Tab

The repair procedure involves adding a "Z" shaped bracket to the underside of the seat. The following steps must be followed to repair the defect. **(WARNING: PROPER EYE PROTECTION MUST BE WORN WHILE OPERATING POWER TOOLS.)**

- Remove the existing seat retaining clip.
- The "Z" shaped bracket must be attached to the "Cushion Frame Support Bar" and the bottom side of the seat. The short leg of the bracket must face the rear of the seat. The bracket must be centered width wise on the "Cushion Frame Support Bar". The front edge of the bracket must be located 1/8 inch to the rear of the front face of the "Cushion Frame Support Bar". Make sure that the bracket will contact both "Seat Support Tabs".
- Using the holes provided in the bracket as a location guide, use a # 16 (0.1770) drill bit to drill three holes in the "Cushion Frame Support Bar" and three holes in the seat cushion plywood base. (Caution - Do not drill completely through the plywood.)
- Install the supplied screws in all six holes.
- Complete and return the self addressed "**RECALL REPAIR REPLY CARD**" included with the kit.

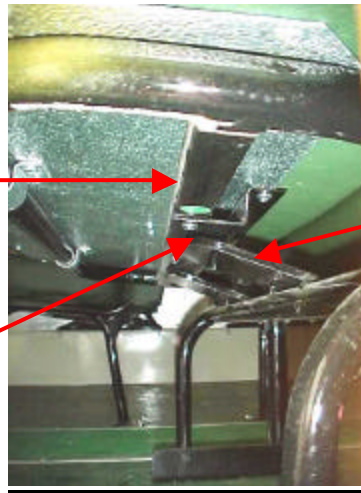
PICTURE SHOWING REPAIRED SEAT WITH "Z" BRACKET
