# VEHICLE RECALL

**G-02507  
July 2002**

**SUBJECT: VEHICLE RECALL (U.S., EXPORT)  
Lower/Horizontal Clutch Rod Replacement on 4300  
and 4400 Models Built from 10/24/2000 Through  
5/30/2002 with Manual Transmissions.**

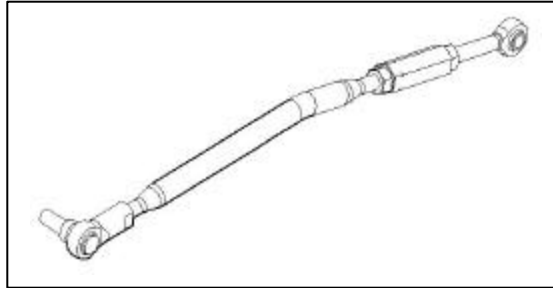
Lower/horizontal clutch rods with turnbuckles may fail from fatigue near the turnbuckle due to bending forces experienced during clutch pedal applications.

**Figure 1: Replace original clutch rod PN: 3544400C91 with turnbuckle.**

**DESCRIPTION:** All vehicles in this recall must have the original lower/horizontal clutch rod replaced. The original rod has a turnbuckle and the new rod does not have a turnbuckle (see Figures 1 and 2 below).

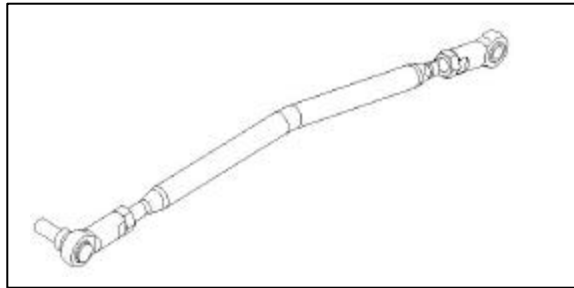
**Figure 2: Install new clutch rod PN: 3532869C91 without turnbuckle.**
