IC Corporation

REVISED RECALL NOTICE

IC CORPORATION RECALL # 03305-R1
NHTSA RECALL # 03V- 354

Roof Topping Sheet Joints

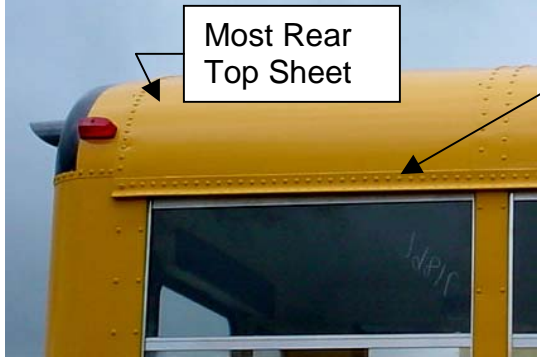
<p>Most Rear Top Sheet</p> <p>Drip Rail</p>

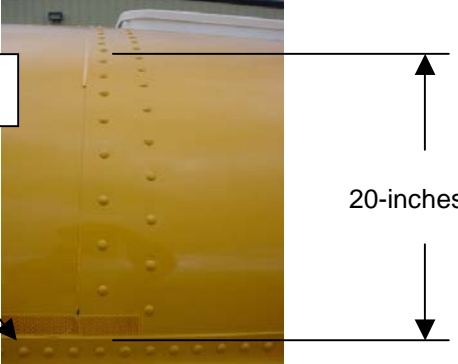
<p>20-inches</p>
<p>Start with the most rear top sheet.</p>	<p>Measure up approximately 20-inches from the drip rail. The inspection measurement can be taken on either the right or left side of the bus. Only one side is required.</p>

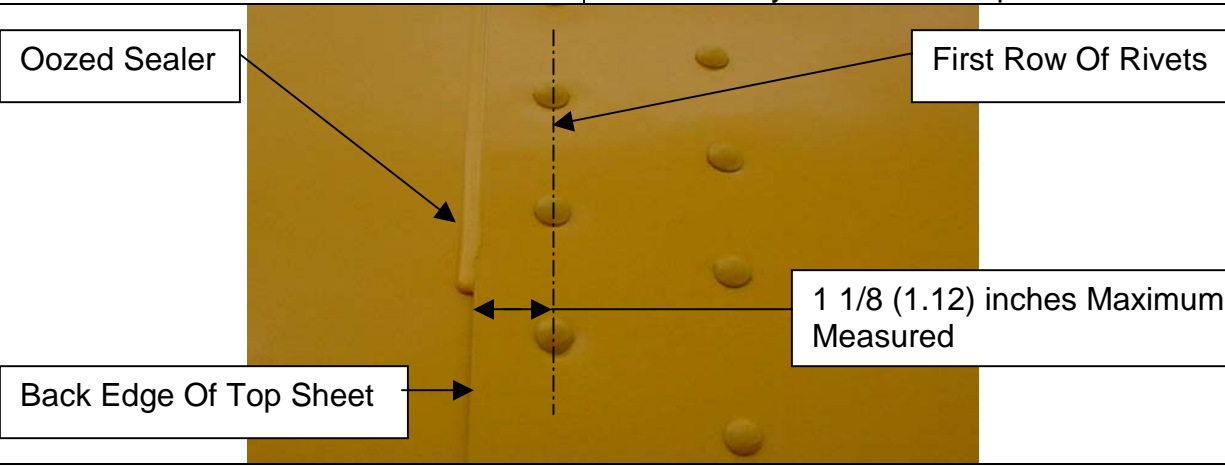
<p>Oozed Sealer</p> <p>Back Edge Of Top Sheet</p> <p>First Row Of Rivets</p> <p>1 1/8 (1.12) inches Maximum Measured</p>	
<p>Measure the distance from the back edge of the top sheet to the centerline of the first row of rivets. Note the most rear top sheet is attached to the rear cap with only one row of rivets and the measurement is taken to that row of rivets. If this distance exceeds 1 1/8 (1.12)-inches the next joint, which contains the covered end of the same sheet involved in the measurement, may be noncompliant and must be repaired. Make sure that the measurement is from the edge of the metal and not the sealer that may have oozed from the joint. If it is equal to or less than 1 1/8 (1.12)-inches, the joint is compliant and does not need to be repaired.</p>

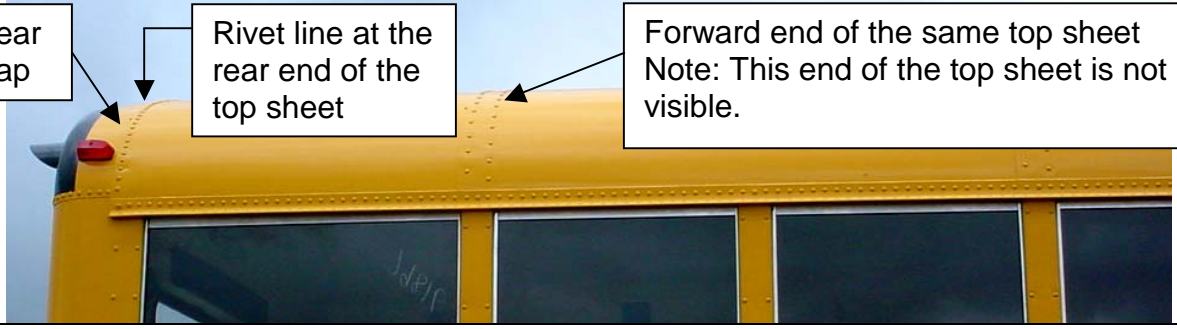
<p>Rear Cap</p> <p>Rivet line at the rear end of the top sheet</p> <p>Forward end of the same top sheet Note: This end of the top sheet is not visible.</p>	
<p>The 1 1/8-inch measurement at the rivet line at the rear end of the top sheet being measured determines if the joint at the forward end of the same sheet is compliant.</p>

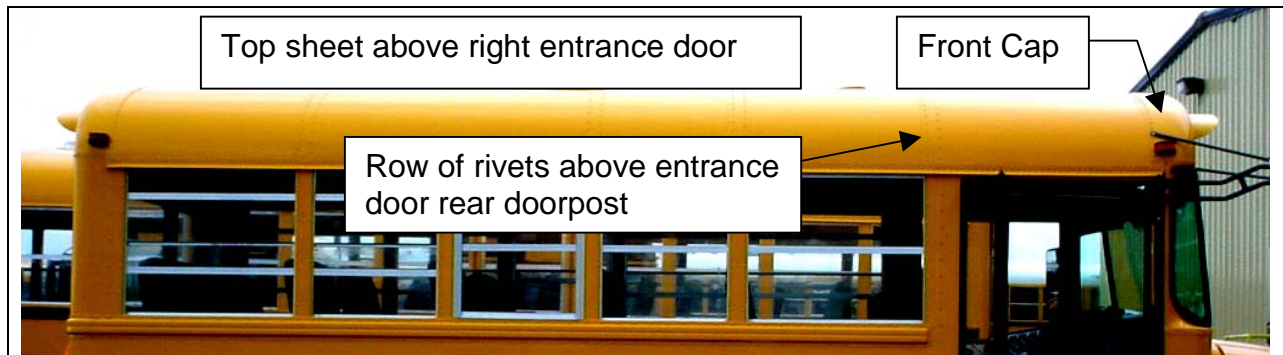
Continue this inspection procedure for the remaining top sheets except the top sheet above the right entrance door. This top sheet above the right entrance door, which attaches to the front cap does not require inspection. Therefore do not measure the row of rivets above the entrance door rear doorpost; it is not part of the inspection procedure.
