# Authorized Field Change

AFC 08901

**Subject:** Hydraulic Full Power Brake System Power Supply

Model: 3200, 4200, 4300, 4400, and HC Bus

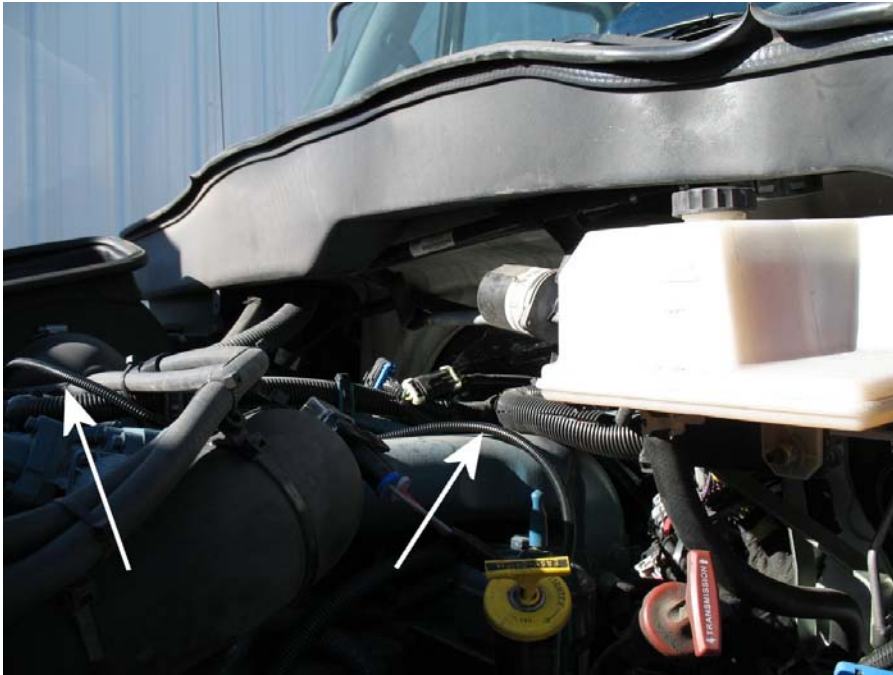
**Figure 2** Arrows are pointing to the new harness as it lays over the engine
