G-05501-R2
May 2005

SUBJECT: SAFETY RECALL (U.S., EXPORT)
FRONT DRIVE SHAFT on 4800 4x4's with FABCO
TC-200 TRANSFER CASES built 6/30/1999 thru
5/8/2002

This Recall is the final remedy and supersedes Safety Recall G-03516

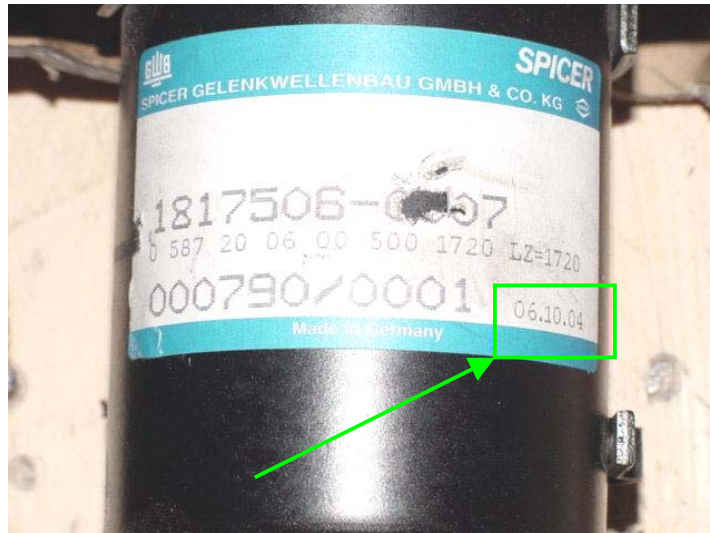
Date Code Location

- Date code format is as follows: DAY.MONTH.YEAR. The example above corresponds to October, 6th, 2005.
- If date code is between **01.06.04** and **11.10.04** (*June 1st, 2004 thru October 11th 2004*), perform the following inspection on the shaft's companion flanges.
- If the date code is after 11.10.04, continue on to **FRONT DRIVESHAFT REPLACEMENT**.
- Inspect the serrations in BOTH flanges for excess material in the FLAT AREA BETWEEN THE SERRATIONS.

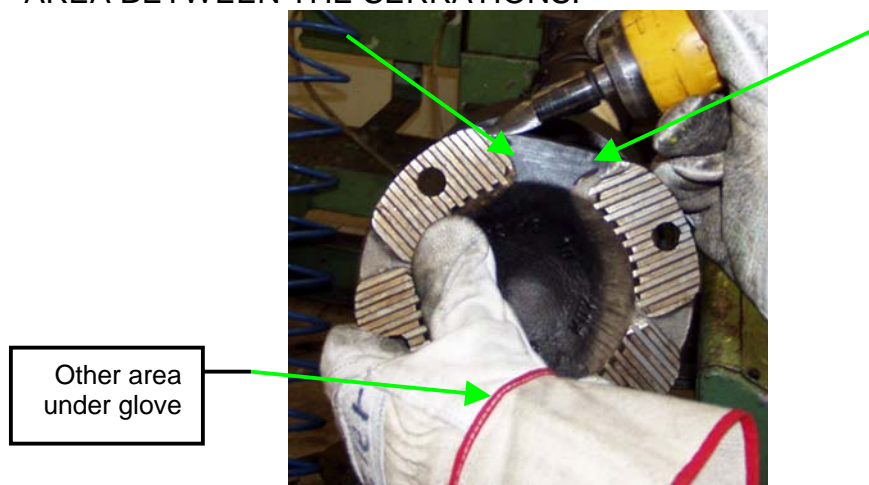
Flange Serrations

THERE MAY BE A BURR ON THE DRIVE SHAFT'S FLANGE THAT CAN PREVENT THEM FROM PROPERLY MATING TO THEIR COMPANION FLANGES.

- If a burr, or excess material is found, use a die grinder to remove it.
 - **DO NOT REMOVE SERRATION MATERIAL.**
 - Use the mating companion flange (transfer case and front axle) as the gauge to check that there is full engagement of the serration or if interference continues to be present.
 - Refer to Step 1 below. Dry fit should indicate full engagement of flange serrations.
- If no burr or excess material is found, ensure dry fit during Step 1 indicates full engagement of flange serrations. Continue to **FRONT DRIVESHAFT REPLACEMENT.**

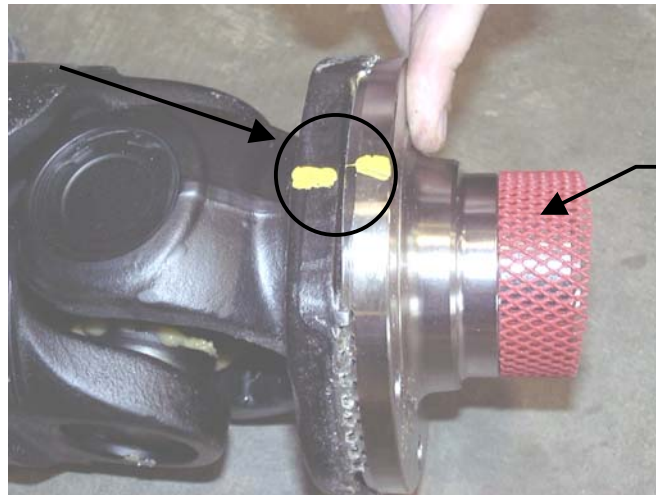
Figure 1 – Front Axle Side – Small Spline

Front Axle Flange has
SMALL Diameter Splines

Transfer Case Flange
has **LARGE** Diameter
Splines

1. Dry fit and lay out the new shaft and flanges to determine which side belongs on the axle side and which belongs on the transfer case side. Mark flange and shaft for ease in installation and proper alignment.

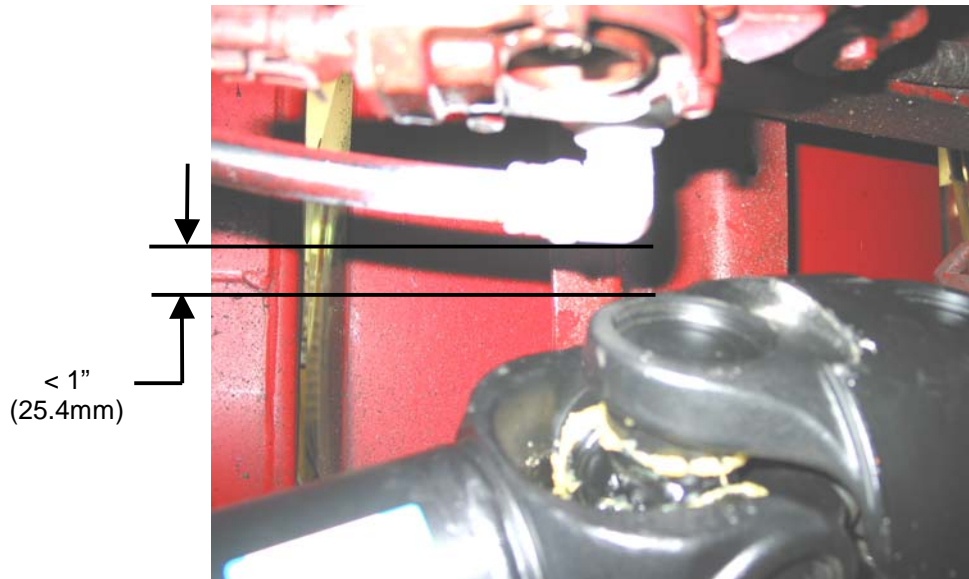
Figure 8

13. Some vehicles built with feature code 804EMZ, air dryer relocation, will require the air dryer to be rotated and re-mounted.
14. If the vehicle's air dryer has an output elbow in close proximity (less than 1" [25.4mm]) to the drive shaft (see Figure 8), a rotation is required. Continue to step 16.

15. If the air dryer elbow is not located in close proximity (greater than 1" [25.4mm]) to the driveshaft, then the dryer relocation is not required.
16. Remove the air dryer mounting bolts. Loosen upper air dryer strap bolts.

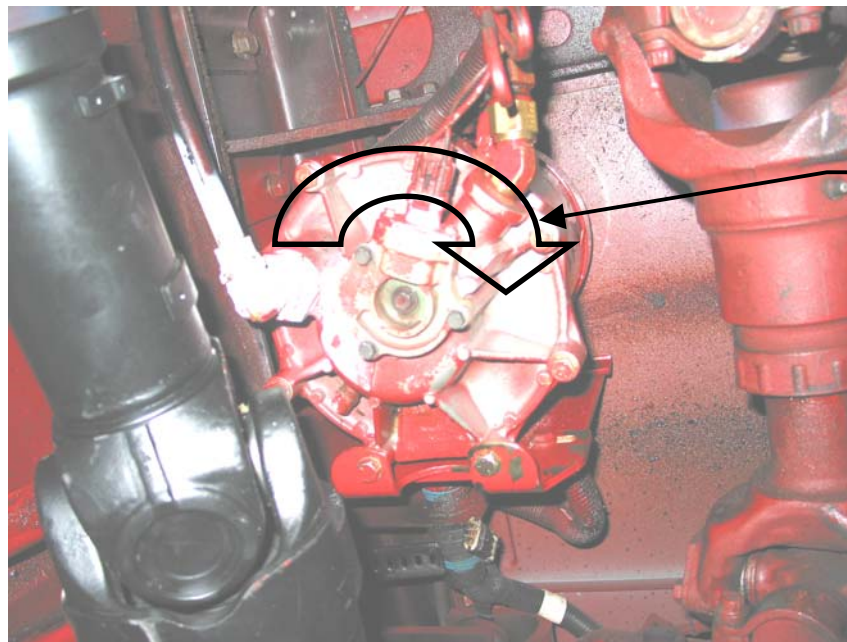
Figure 9 – Rotated Air Dryer

Rotate Air Dryer
Clockwise to this
position.

17. Rotate air dryer and re-install mounting bolts; tighten strap bolts.

NOTE: Please only rotate one (1) mounting bolt position.
