G-04512-R1

March 2005

**SUBJECT: SAFETY RECALL (U.S., EXPORT)
POWER STEERING HOSE ROUTING, ENGINE
HARNESS ROUTING and OIL PRESSURE SWITCH
on certain MODEL YEAR 2005 RE BUS models built
3/3/2004 thru 8/5/2004 with I6 engines only.**

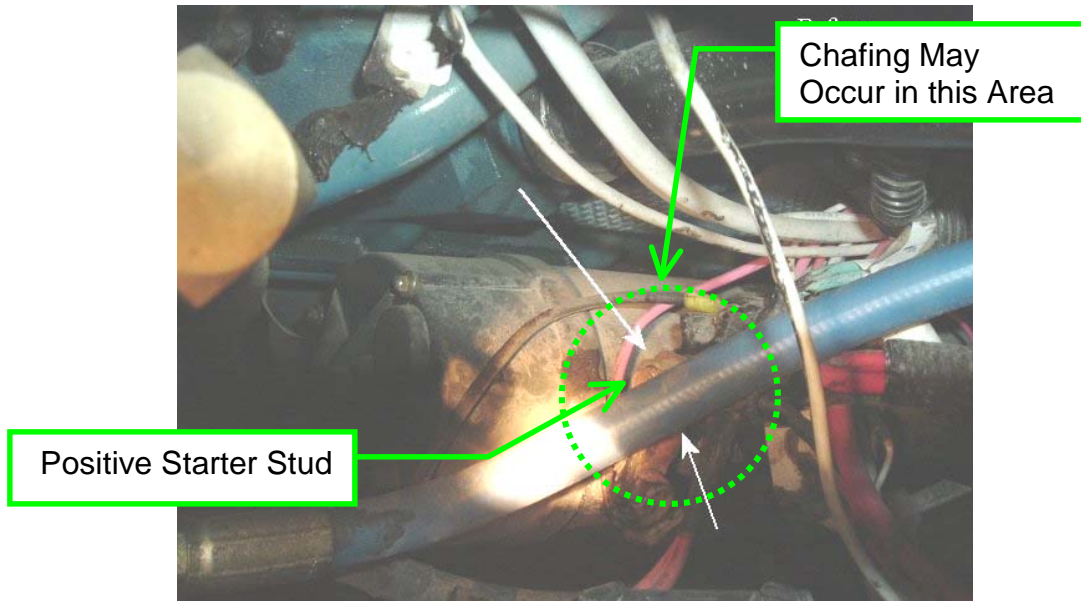
Figure 1

1. Inspect power steering hose for chafing damage in area near where it may have been in contact with the positive stud of the starter solenoid.

2. If any chafing has taken place, replace power steering hose, refill reservoir AND install conduit and strap-locks as indicated below.
3. Install conduit onto power steering hose. Ensure conduit runs from power steering pump to at least forward of bell housing, or clear of engine block.

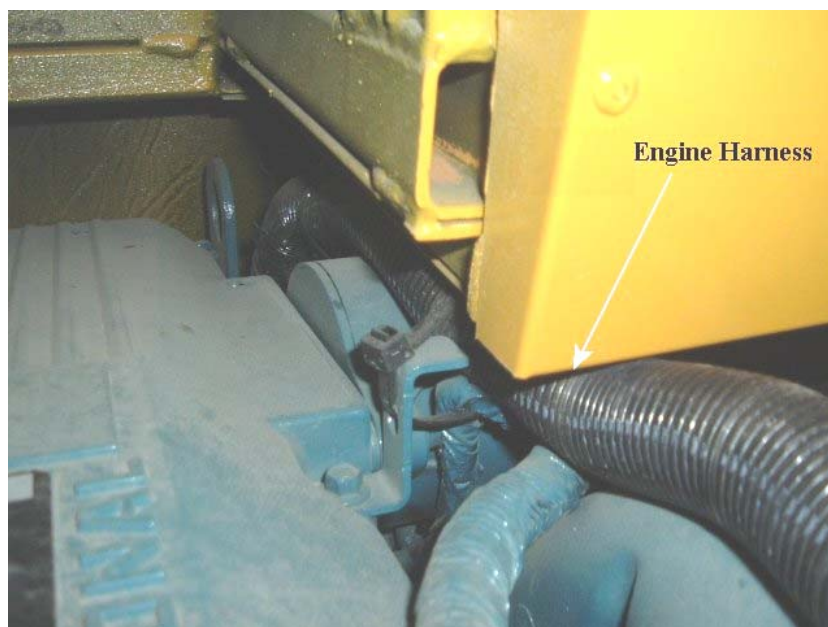
Figure 5

1. If the engine harness appears to be pinched on the right side at the rear of the engine air intake manifold and body, as in the figure below, re-route as indicated.
