Authorized Field Change

AFC G-07910

Subject: Upper Radiator Pipe

Model: ProStar

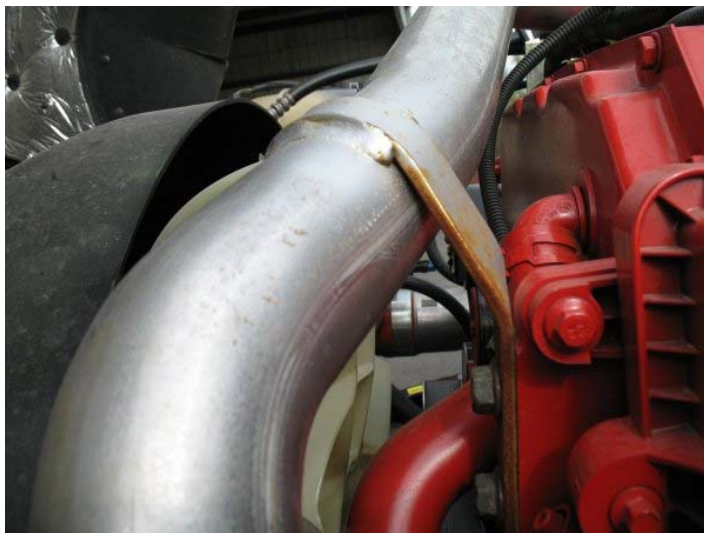
Figure 1

It has been determined that the upper radiator pipe can crack in the areas of the welded-on bracket. The cracking is caused by excessive stresses created by the welding process and/or assembly condition. The crack can result in a coolant leak. The repair is to replace the pipe with a new one that is secured to the engine with a separate bracket and U-clamp. The vehicle should first be inspected to see if this repair has already been made. If it has not, follow the instructions below to make the repair.
