IC Corporation

SAFETY RECALL 05504

Brake Pedal Pivot Bolt Locknut

April 2005

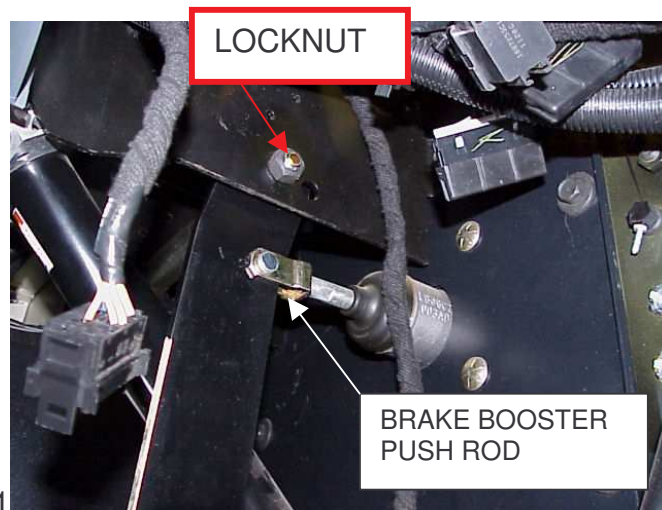
During the assembly of these vehicles, the locknut that holds the bolt in the brake pedal pivot bracket may not have been tightened sufficiently. Normal use of the vehicle may result in the locknut loosening and the pivot bolt falling out of the bracket.

See Figure 1 for the location of the locknut in a bus.

1. Inspect the locknut. The locknut is located on the right hand side of the pivot bracket, above the brake pedal. **Do not confuse this locknut with the nut on the brake booster push rod below it.** See Figure 1.
2. If the locknut appears to be tight, check the torque.
Proper torque for this locknut is 75 to 85 ft-lb.
3. If the locknut is torqued above or below this range, proceed to step #4.
If the torque is within this range, no further action is necessary.
4. Remove the locknut. Care must be taken to not allow the pivot bolt to back out or the bushings to fall out of the assembly. See figure 3.
5. Inspect the locknut for damage.
If the locknut is not damaged, continue.
If the locknut is damaged, replace the locknut and continue.
6. Place the locknut onto the pivot bolt.
7. Tighten the locknut to 75 to 85 ft-lb of torque with a torque spec tool.

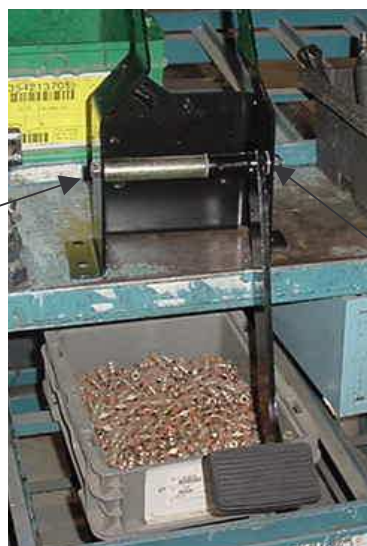
See Figure 2 for a view of the pivot bracket and brake pedal assembly.

Pivot bolt

Pivot bolt locknut

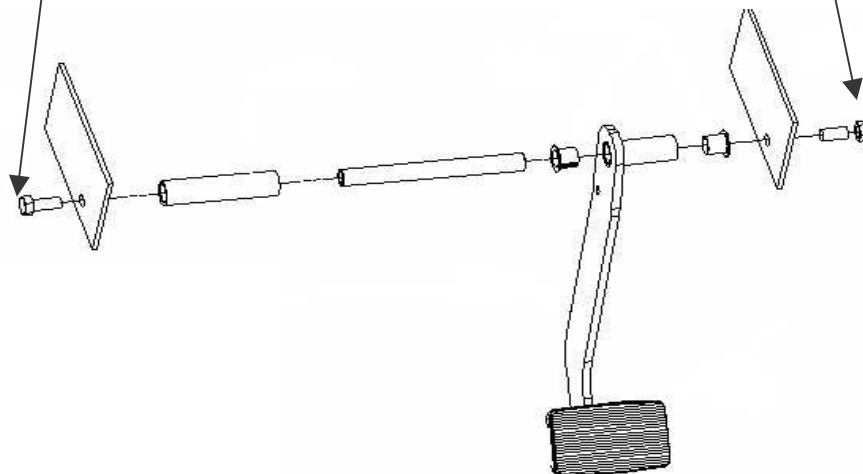
See Figure 3 for a drawing of the complete pivot bracket assembly.
