Authorized Field Change

AFC G-06913R2

Subject: Meritor Rear Tandem Axle Adjuster Lock Screw Breakage

Retrofitting an Additional Adjusting Ring Lock Capscrew on Certain Meritor RT-40-145 Series Tandems (Rear-Rear Axle Only) Built Between March 15, 2004, and February 2, 2005

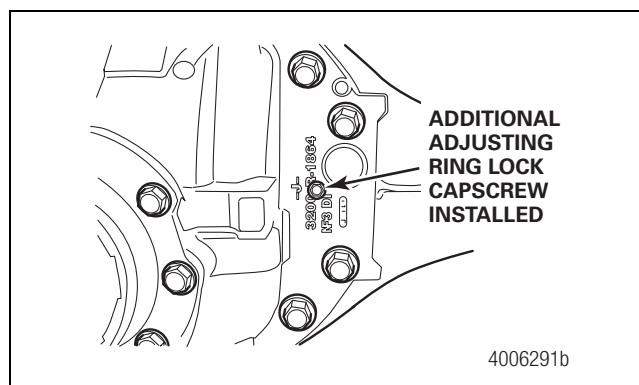
Inspect the carrier flange surface to determine if an additional adjusting ring lock capscrew has been installed. Figure 1 shows a carrier flange with an additional adjusting ring lock capscrew already installed.

- **If you find that an additional adjusting ring lock capscrew has been installed onto the carrier:** Do not perform the procedure. Record the vehicle identification number (VIN) and axle serial number, and report them through the appropriate original equipment manufacturer (OEM) or ArvinMeritor channel.
