# VEHICLE RECALL

**G-01514 REVISION A  
JUNE 2002**

**SUBJECT: VEHICLE RECALL (U.S., EXPORT)**

**Reprogramming the ESC to Prevent Software Fusing  
of the Headlights on 4300 and 4400 Models Built  
from 10/24/00 through 11/07/01.**

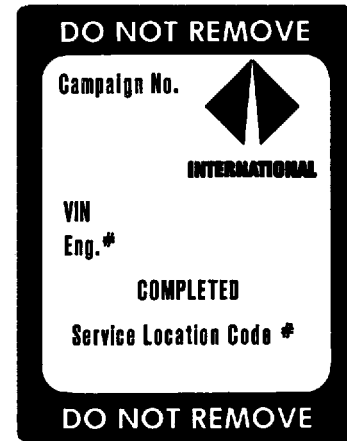
Each vehicle corrected in accordance with Campaign G-01514 will require a CTS-1075 Campaign Identification Label.

Attach the CTS-1075 label on a clean surface next to the vehicle identification number (VIN) plate.
