# Technical Service Information

TSI-05-13-01

**Subject:** Minimal Lever Engagement or Jump Out on Eaton 8LL or 9LL Transmissions

## Service Bulletin: TMIB-0148

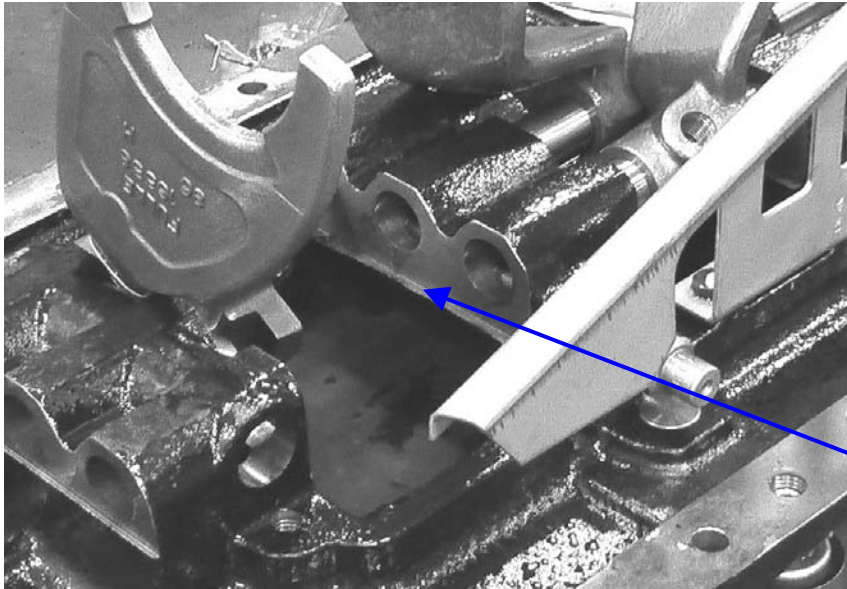
**Figure 1a**

Some customers with 8LL or 9LL transmissions may experience a complaint of minimal lever engagement or lever jump out in the rearward lever positions. This condition is caused by an improper machining operation at the shift bar housing resulting in casting interference with the shift blocks.

Shift bar housing shown with shift bars removed for viewing purposes.

Area of Machining  
Defect

If any of the above symptoms are present the shift bar housing should be removed from the transmission to inspect for this condition. The shift bar housing must be placed upside down on a bench for inspection (see figures 1a and 1b). If this condition is present the repair instructions below must be followed.

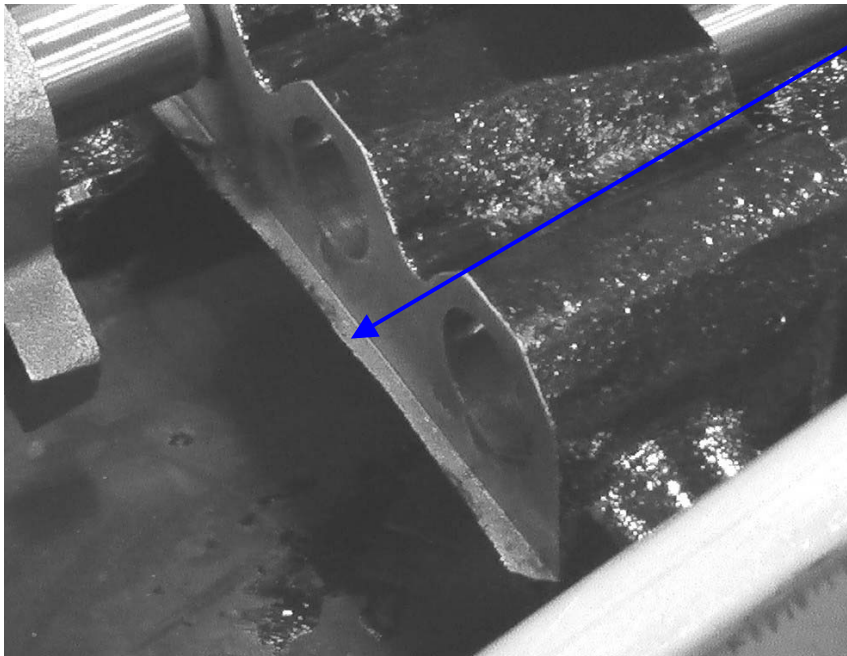
**Figure 1b**

Enlarged View

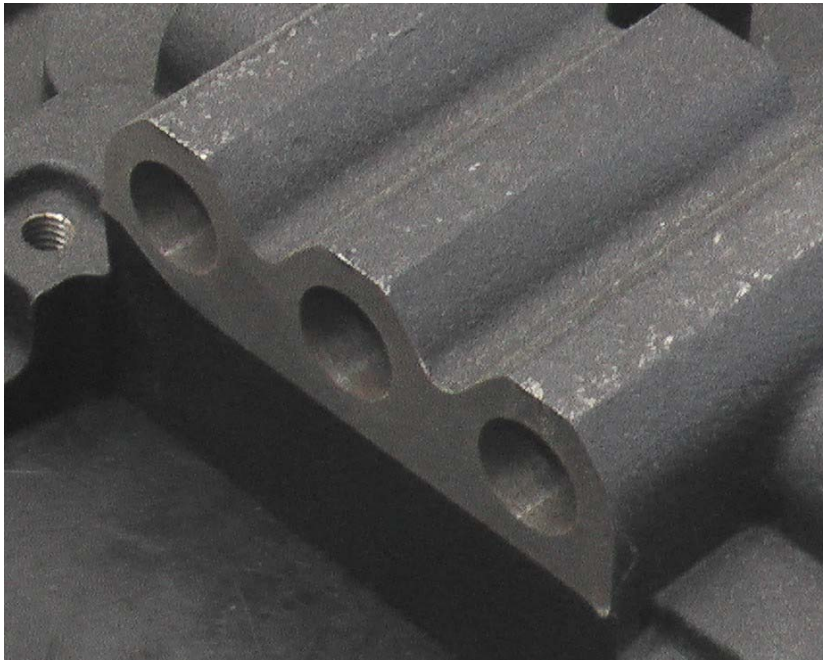
**Figure 2**  
Excess material removed

Step 2. Use a small grinder to remove the excess casting material until the surface is free of raised material. (see figure 2)

Step 3. Thoroughly clean the shift bar housing to eliminate any contamination from the grinding operation
